Upton, MA

Nutrient Source Identification Report

MS4 Permit Year 4

June 2022

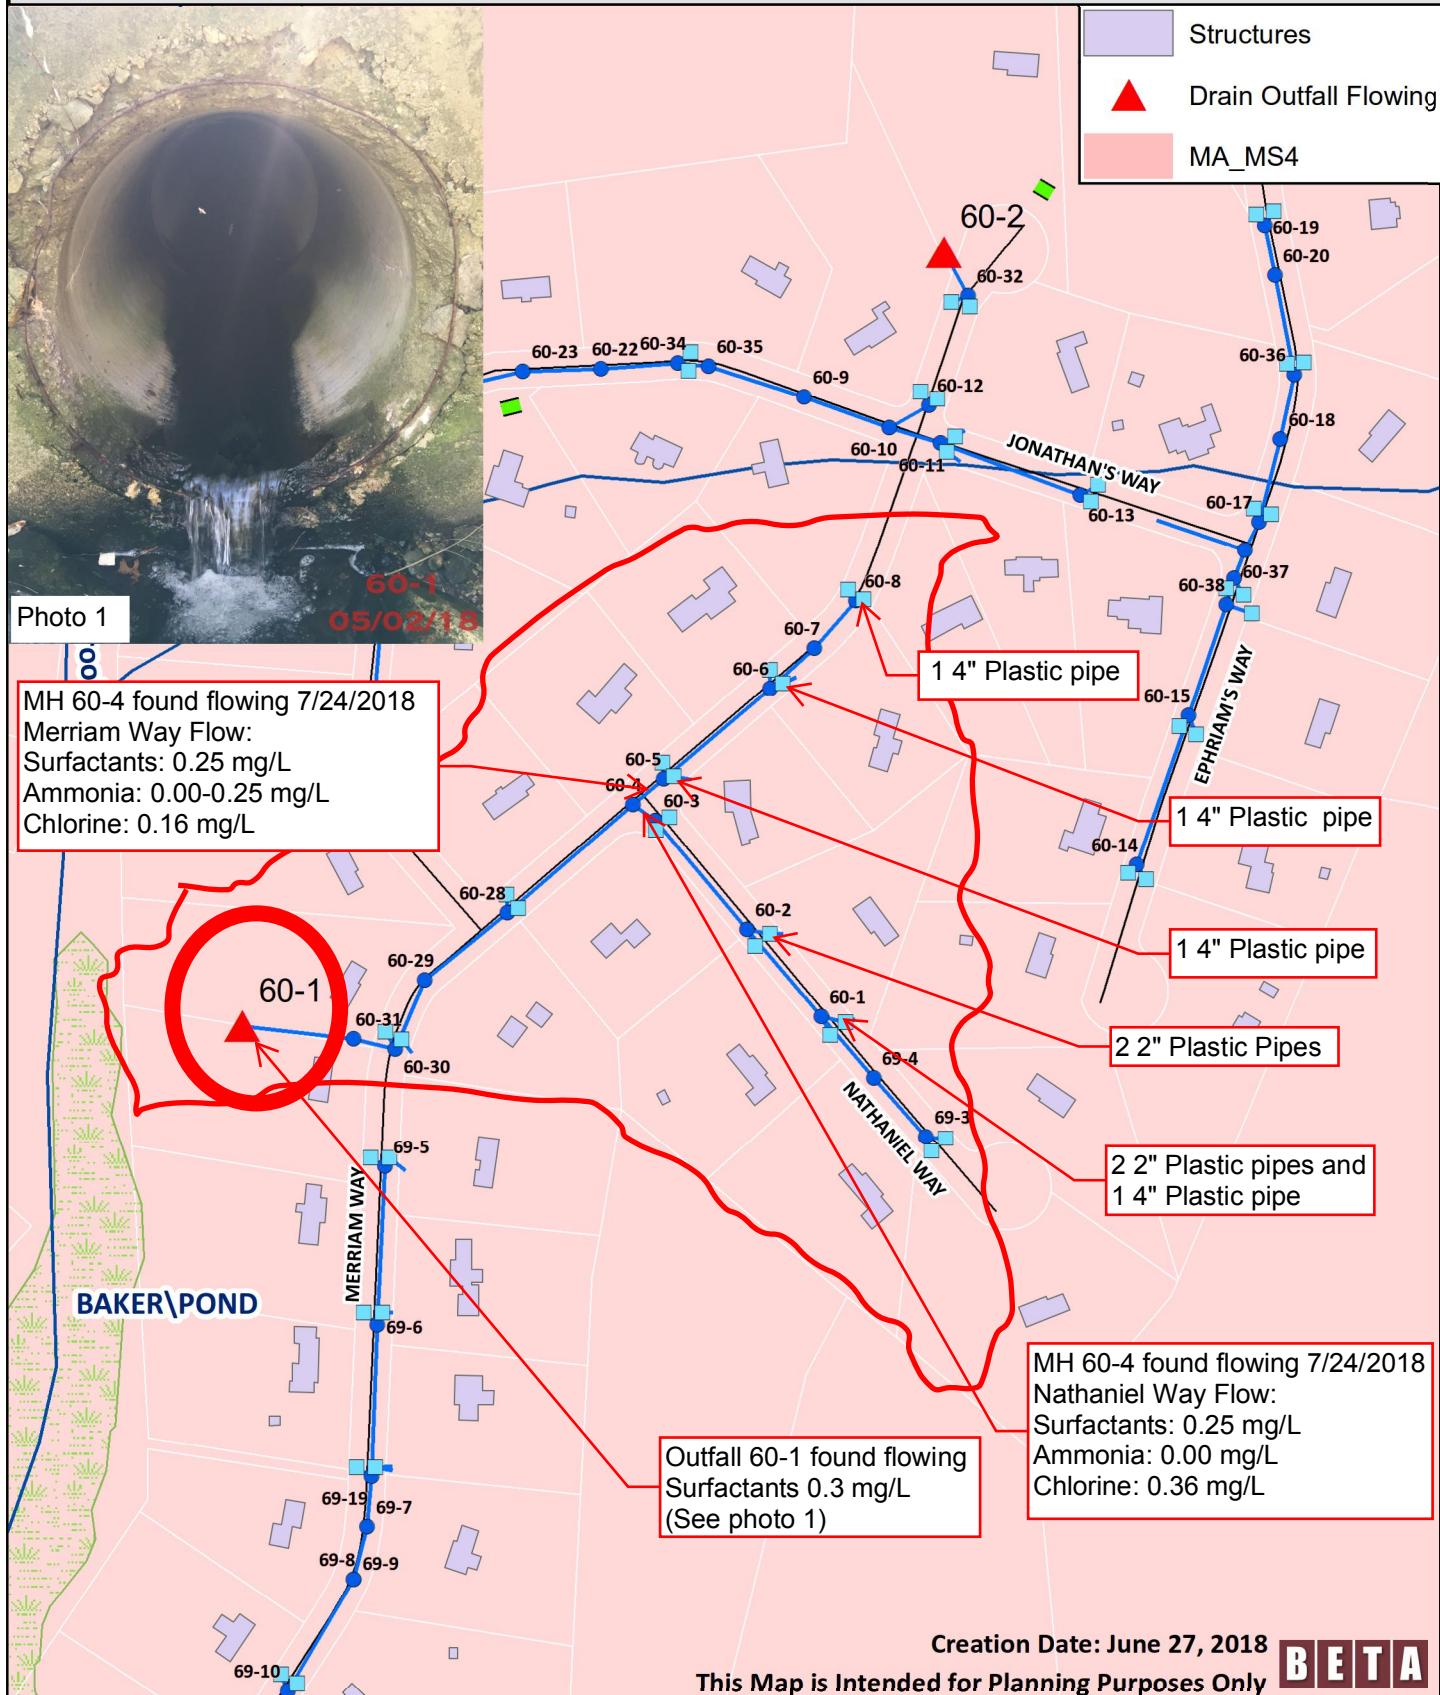
Figure 2: Outfall 60-1

Outfall 60-1 –BETA visually inspected and tested key junction MH 60-4 on July 24, 2018. Pipes entering MH 60-4 from Merriam Way and Nathaniel Way both tested positive for surfactants and chlorine. Field tests were conducted July 30, 2018 on all flowing manholes upstream of MH 60-4. Manhole 60-5 was the only flowing MH and tested positive for Chlorine (**0.62 mg/L**) and Surfactants (**0.25 mg/L**). All other drainage structures upstream of MH 60-4 on Merriam Way and Nathaniel Way were visually inspected for other pipe connections. Multiple plastic pipes were found discharging into catch basins. See Figure 2 for identified Catch Basin connections. Testing results for OF-60-1 can be found in Table 1 (attached).

Dry-weather screening and sampling found evidence of contamination at two of the fifteen outfalls. Outfall **60-1** was found to have **0.30mg/L** of surfactants, and the key junction MH 60-4 was found to have contamination from both chlorine and surfactants. A catchment investigation indicated pipes entering catch basins on Merriam Way and Nathaniel Way. A direct connection to a catch basin is not always illicit, these pipes could be from a sump pump, floor drain, or discharging wash water. Outfall **78-3** was found to have **0.08 mg/L** for Chlorine and **1800 CFU/100mL** for E.Coli. There are no records of sewer on Mendon Street and most of the homes were built in the early 20th century, which indicates most homes are on septic. There are records of sewer on Pleasant street, with a main crossing the drainage pipe.

- Educating and outreach to homes in the OF-78-3 catchment area to encourage good storm water practices, and to notify BOH for potential septic failure/issues.
- Conduct a sewer main inspection at the intersection of Pleasant Street and Mendon Street to locate potential exfiltration.
- Contacting homes in the OF-60-1 catchment area with catch basin connections (sump pumps, floor drains wash water), to determine the discharge source.

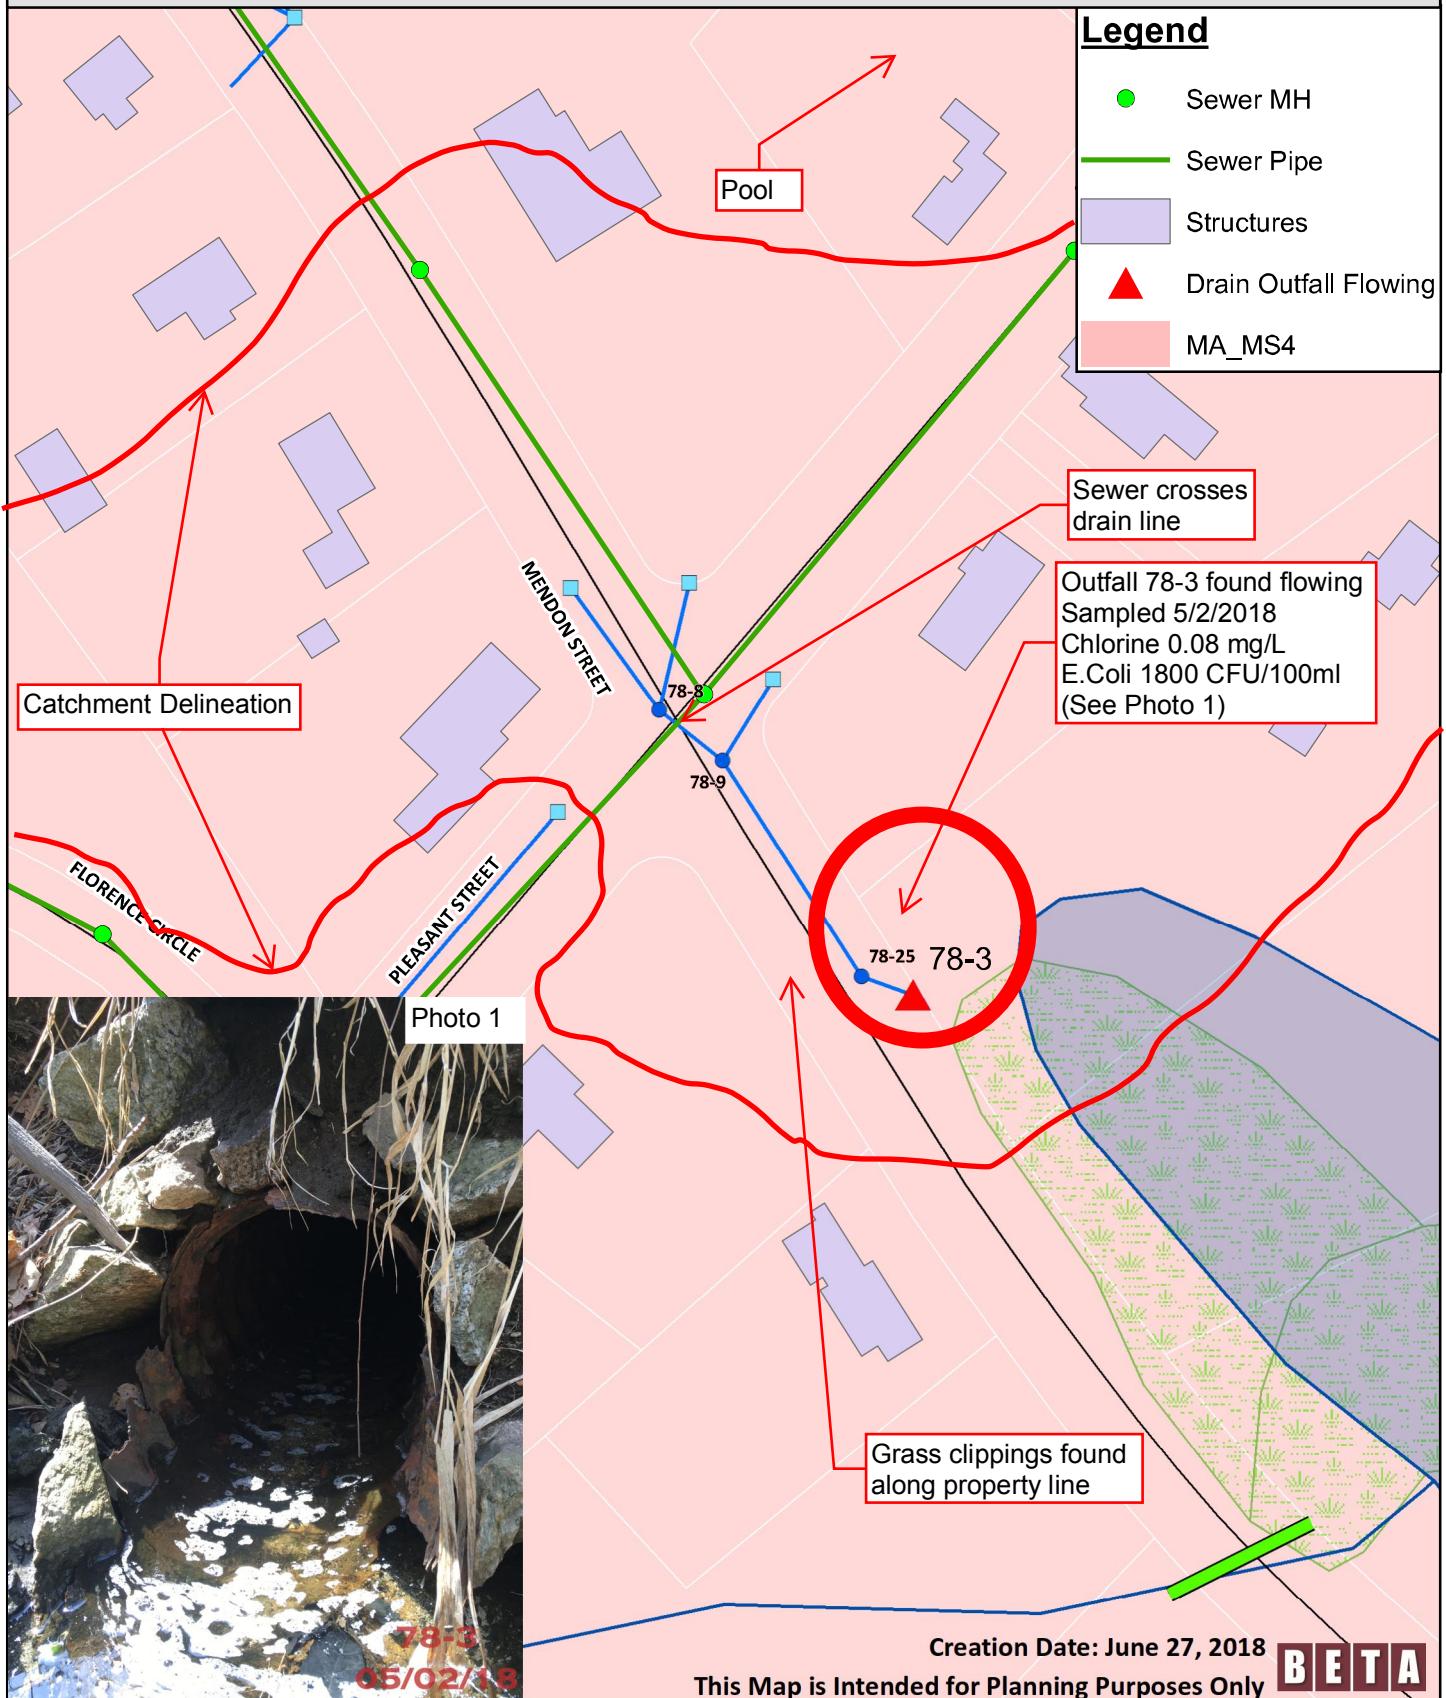
Figure 3: Outfall 78-3

Outfall 78-3 –BETA visually inspected the catchment area of OF 78-3 on July 24, 2018 to determine possible reasons for a positive E.Coli result. During the inspection, a large pile of grass clippings were found at 48 Pleasant Street across from the outfall, and a pool was located at 39 Pleasant Street. Information acquired offsite from the Upton Assessor's office indicate this area is made up of early 20th century, single family homes. Pleasant Street has sewer which crosses Mendon Street. BETA visually inspected the drainage structures on August 10, 2018, and did not find any illicit connections. See Figure 3 for the locations of observations recorded July 24, 2018.
