MEMORANDUM

DATE: OCTOBER 28, 2025
TO: WESTON & SAMPSON
100 FOXBOROUGH BLVD, SUITE 250
FOXBOROUGH, MA 02035
ATTN: MR. MIGUEL PIMENTEL
PROJECT DESIGNER III
CC: LANCE ROBSON, BET
FROM: GRAHAM CARR, PE
RE: ROOF & EXTERIOR RESTORATION
UPTON TOWN HALL
1 MAIN ST, UPTON, MA 01568

BET
PROJECT NO: 25083

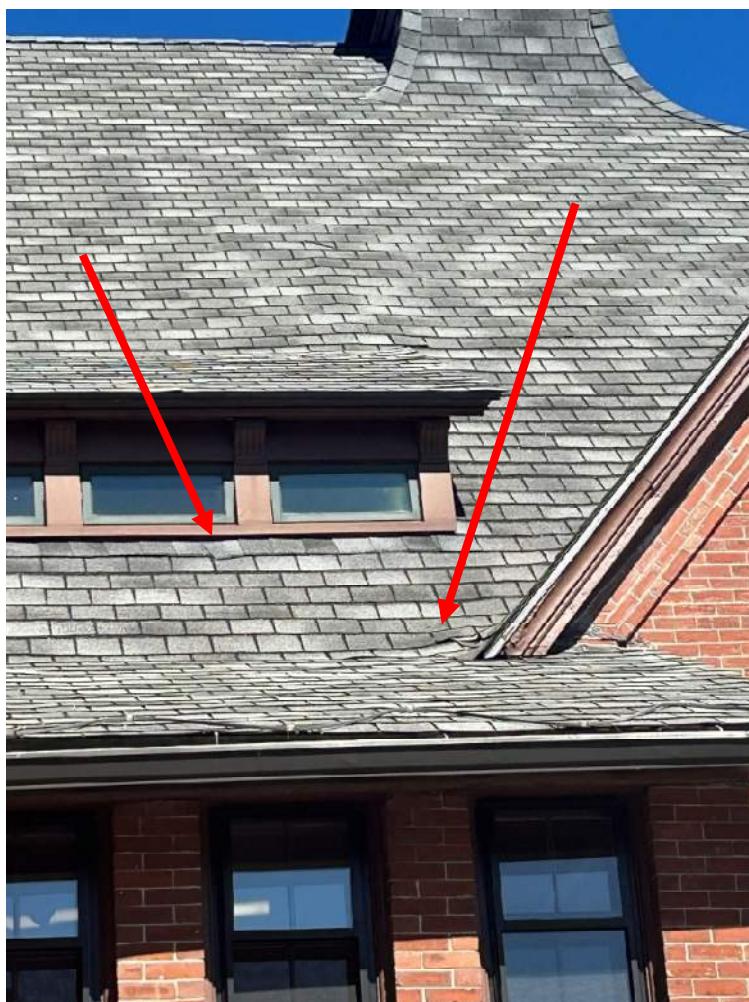
South elevation – lifted shingles at bottom of a valley, and damaged shingles at a dormer rising wall.

Also note heat trace wiring installed to prevent ice dams.

1. Remove and replace roof systems on the building, including the following considerations.
 - a. Roofing, underlayment and flashings should be replaced 100% using similar style architectural shingles, asphalt underlayment, step flashing, valleys and penetration flashings.

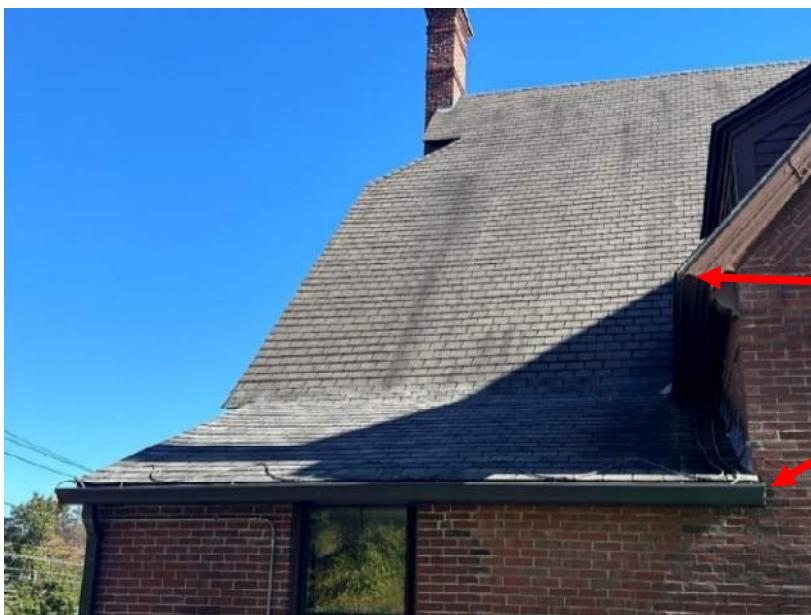
West elevation , Northwest corner – overview of roof conditions.

Note the upper roof drains over the roof edge onto a lower roof below.

Also note that there is no kickout flashing present, and masonry is deteriorated / previously repairs below.

- f. Install kick-out flashings at locations where a roof eave intersects a wall. Detail kick-out flashings continuously with new step flashing.
 - g. Install gutters and downspouts at roof eaves which currently drain over the roof edge to the ground. New downspout leader locations must be coordinated with the site to avoid ice/water accumulation. Consultation with a site/civil engineer may be required.

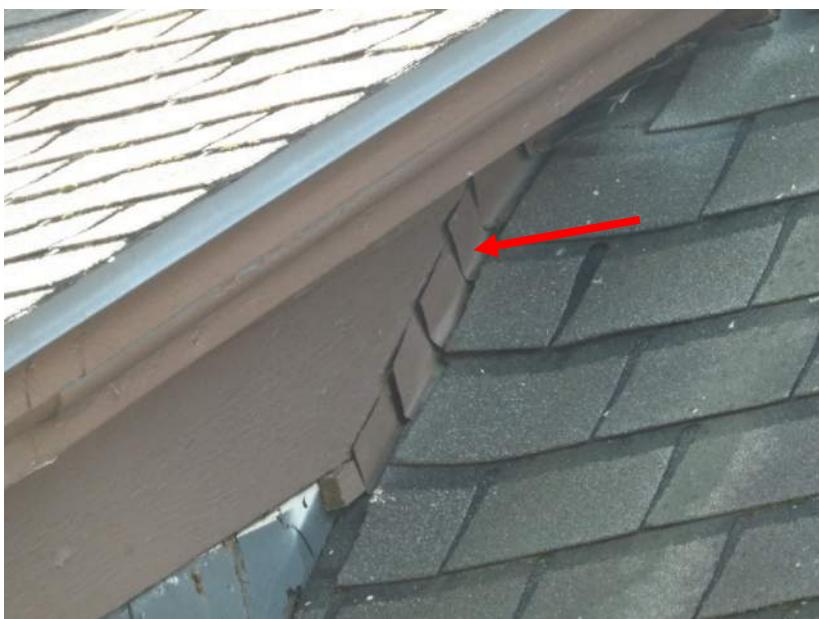
Shed dormer cheek with step flashing poorly placed over rake trim.

- b. Siding, slate shingles, corner boards and above-roof trim on dormers and rising walls must be removed to install new roof underlayment and step-flashing.

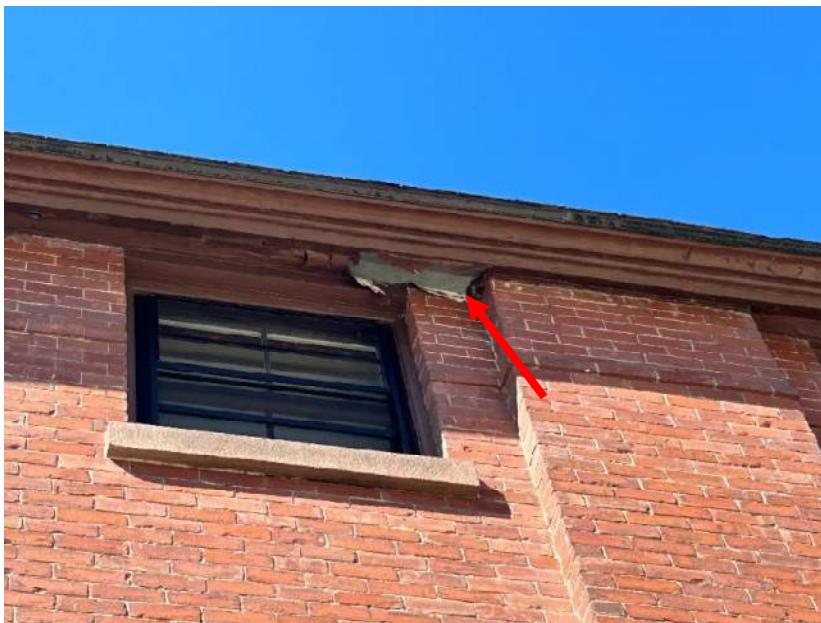
Peeling / failed paint at eaves. Note that the roof in this area drains directly over the edge with no gutter.

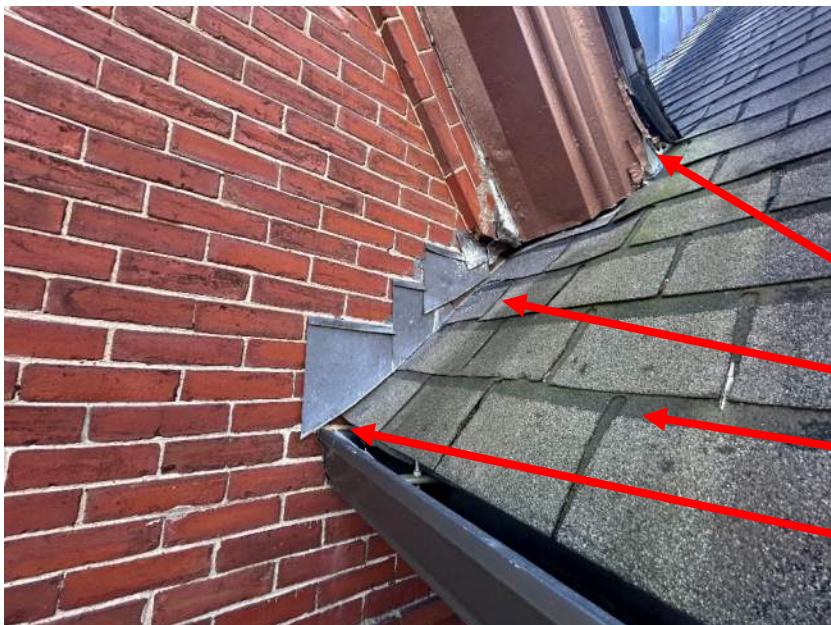
North elevation – roof area below valley and above North alcove roof. Note the following compounding conditions:

Poorly detailed flashing, gaps in flashing.

Loose/displaced shingle.

Concentrated / bulk water from valley.

No kick-out flashing provided at gutter-to-cheek wall.

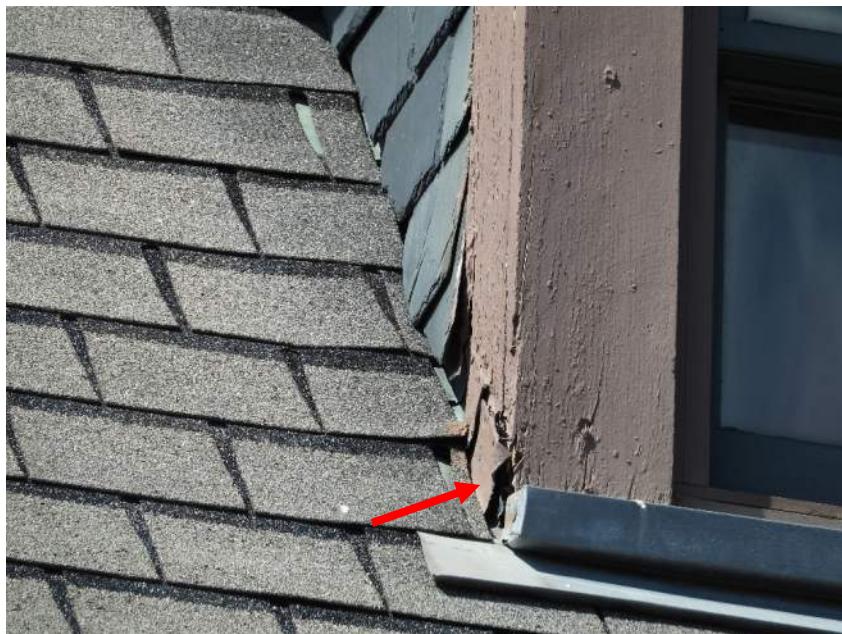
Wood corner board trim at dormer wall – note that the step flashing is incorrectly placed over the trim, and the trim is aged / deteriorated in high moisture areas.

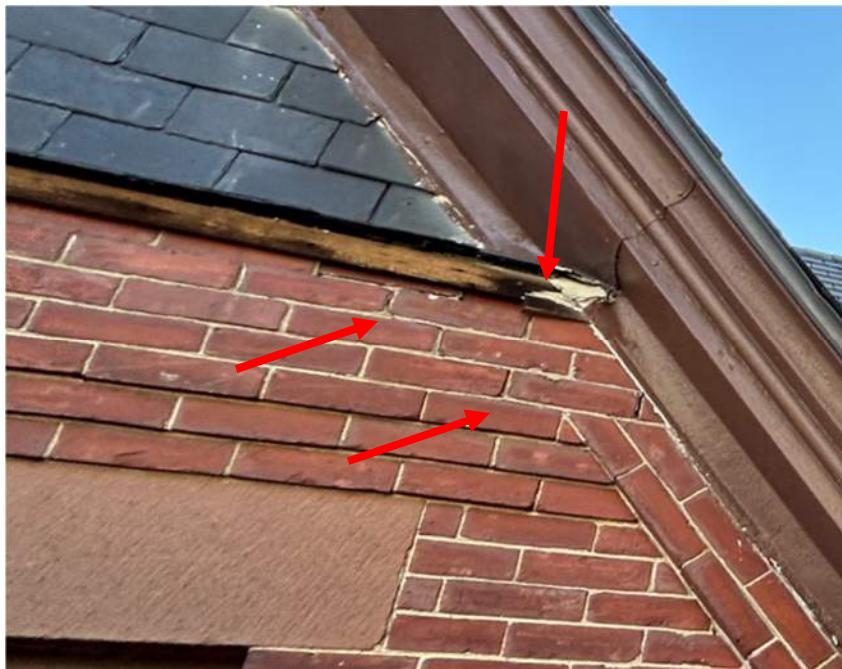
Deteriorated wood trim / nailing.

Step cracks in masonry.

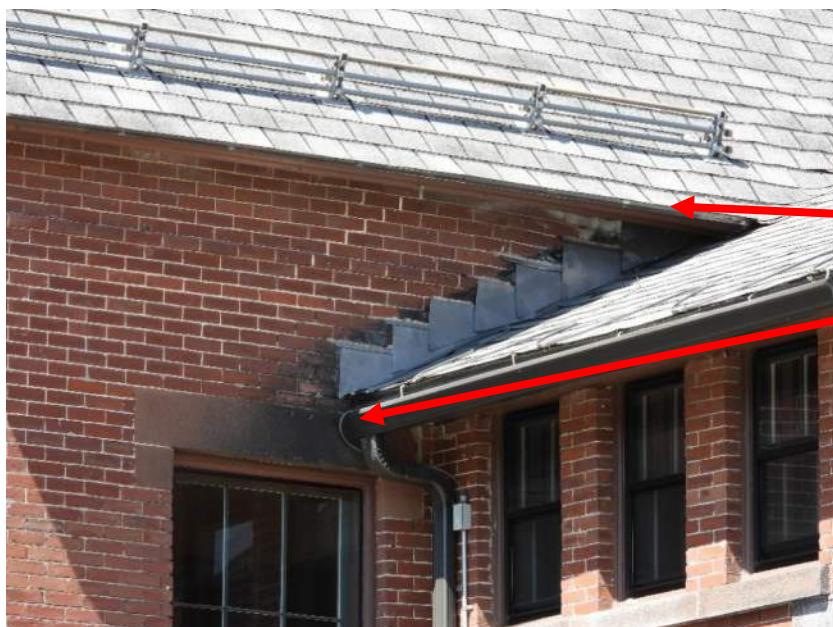
South elevation return wall – roof drainage concerns above deteriorated masonry wall and foundation wall.

Upper roof drains over edge onto wall and lower roof plane.

No kick-out flashing.

Note the staining on masonry and brownstone, likely due to splashing effects of roof drainage.

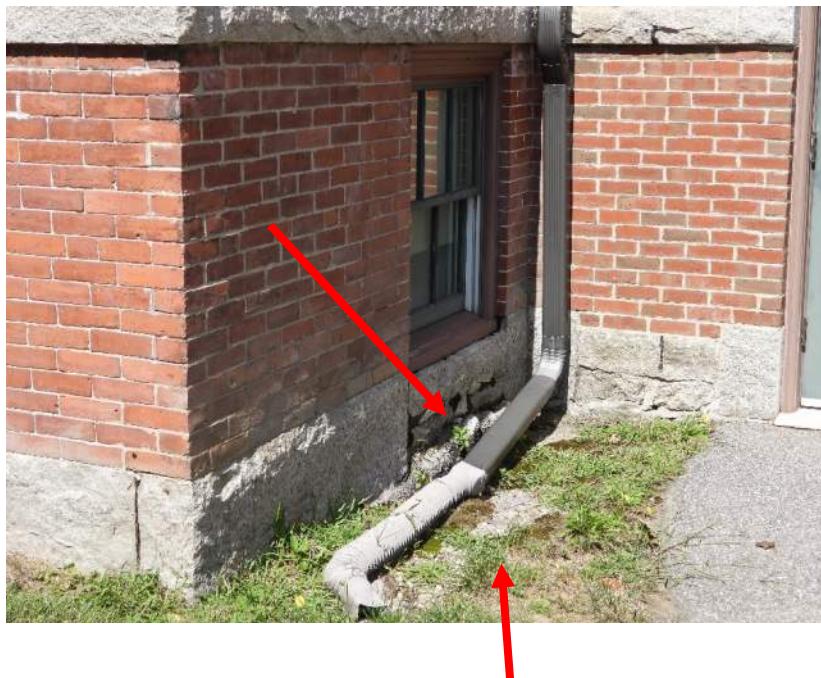
South elevation return wall – loose/deteriorated fieldstone.

Note that the upper roof plane drains onto the ground – splash marks can be seen on the masonry.

- c. Re-point chimneys, cheek walls, rising walls and other masonry areas above the roof line 100% which receive step flashing for the roof.
- d. Repair cracks and re-set stone units in deteriorated fieldstone foundation walls. Excavation and removal of interior finishes are expected for the fieldstone repair at the South elevation return wall.

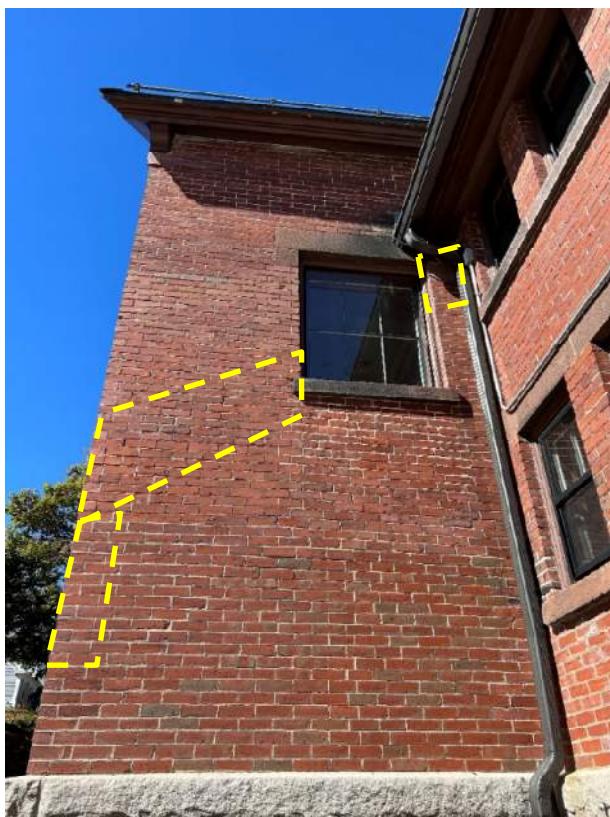
Overview of South elevation return wall

Masonry mortar joints are generally deteriorated.

Yellow areas indicate fresh step cracks and vertical cracks. Previous crack re-pointing has been completed.

Cracking patterns and uneven coursing indicate settlement and/or downward displacement of the masonry above the deteriorated fieldstone foundation wall.

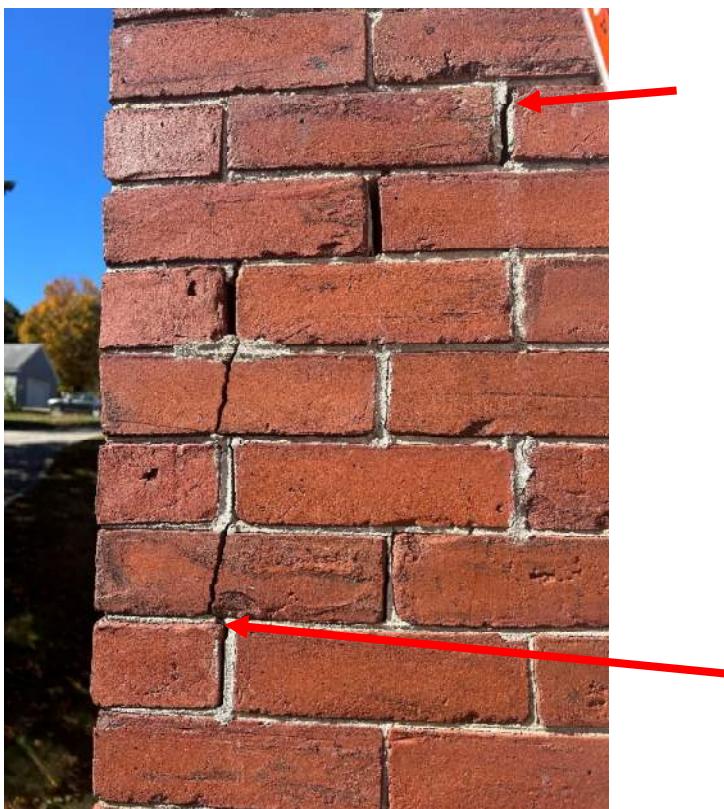
South elevation return wall – detail view of step cracks and vertical cracks at corner.

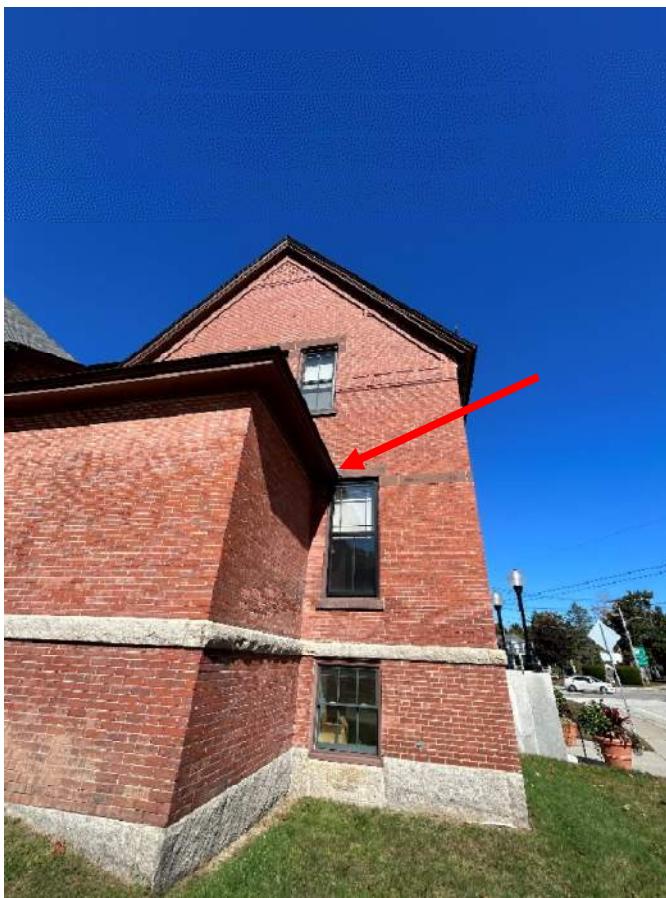
South elevation, Southeast corner.

Roof edge located directly above the Clerk's office window.

Periodic leaks have been reported at the Clerk's Office window, located at the South elevation, Southeast corner on the first floor. Exterior conditions above this window include a hip roof with no gutters. Roof-to-cheek wall detailing includes lead step-flashing that ends above the window with no kick-out flashing. Bulk water freely drains directly onto the window head from the hip roof. This condition is compounded during wind driven rain from the South / Southeast directions.

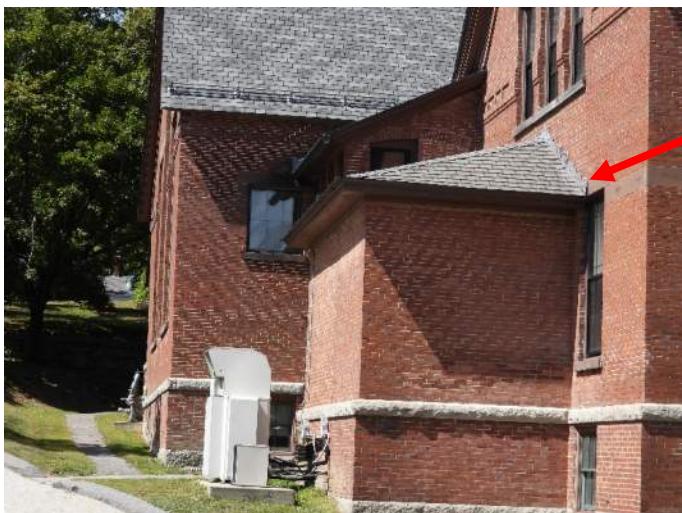
South elevation, Southeast corner.

Note that there is no gutter/kickout flashing above the window in question.

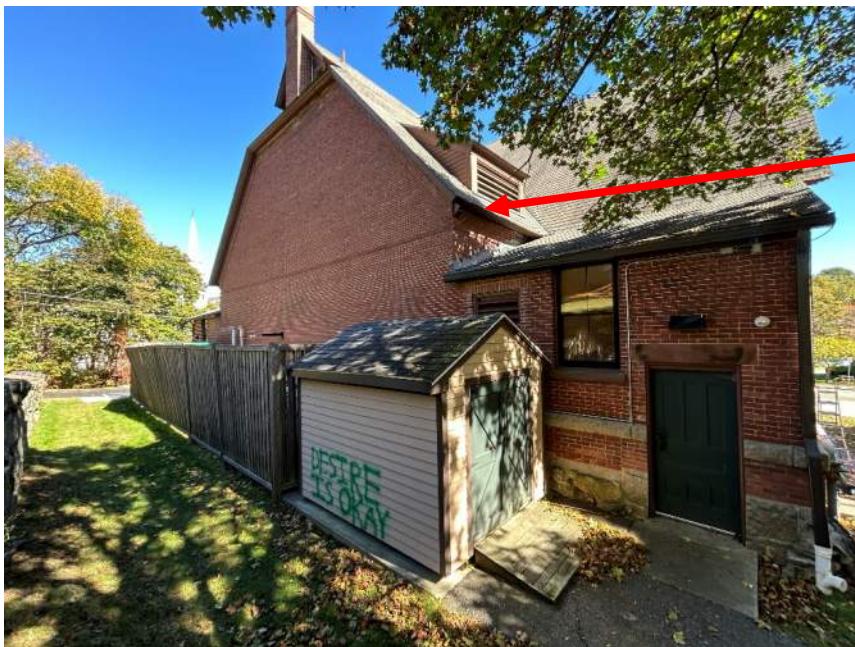
West elevation, Southwest corner.

Main roof drainage appears to bypass the gutter by drainage off of the upper roof plane, compounded by a lack of kick out flashing.

Masonry step cracks and moss growth were noted below this roof condition.

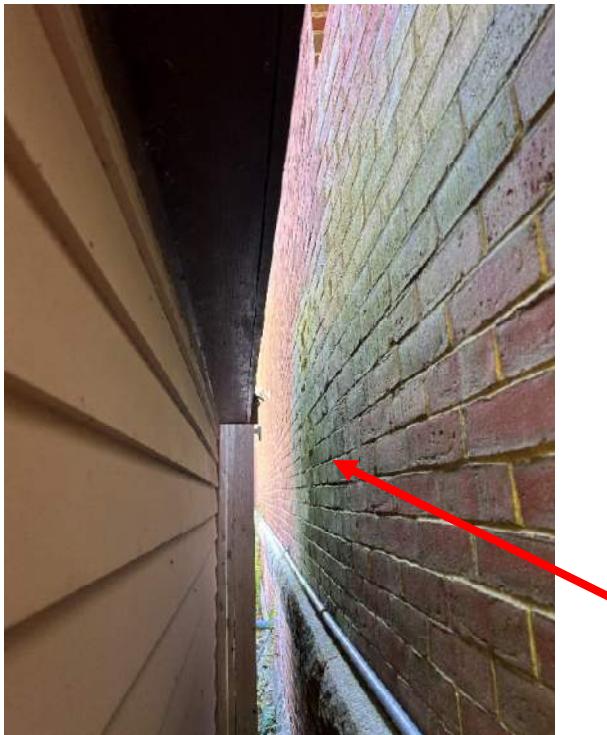
West elevation, Southwest corner.

Moss growth and staining on inaccessible masonry wall behind shed, aligned with the shed roof eave height.

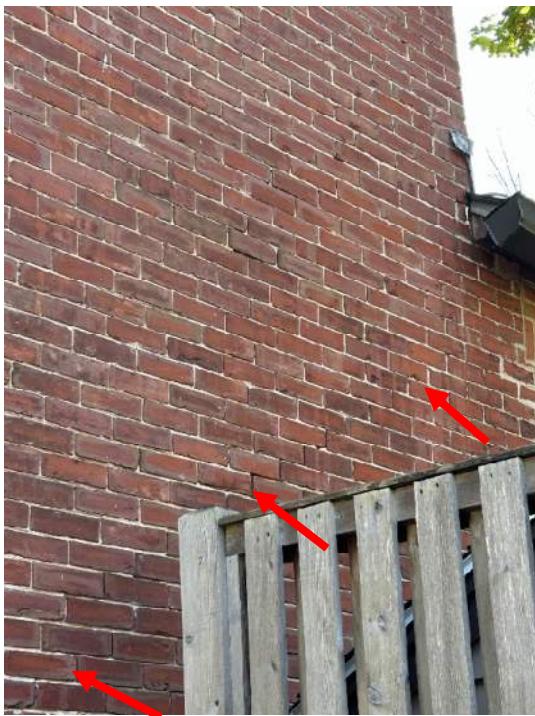
Masonry step cracks at West elevation, Southwest corner, North of the shed.

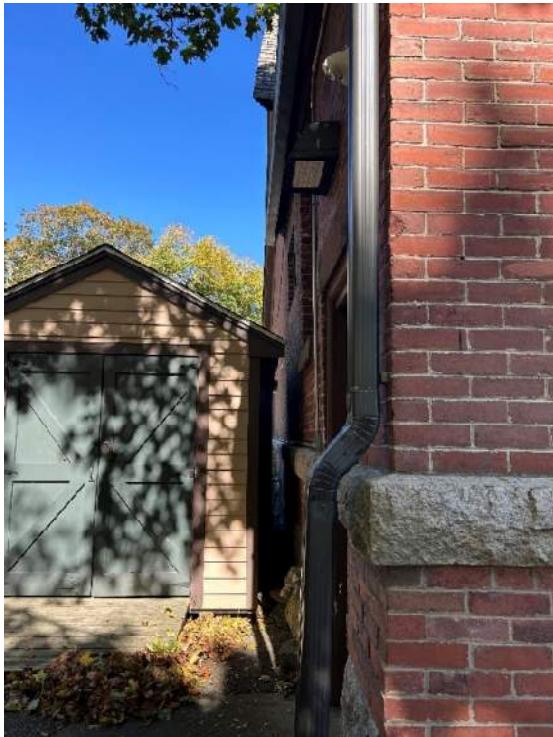
West elevation, Southwest corner. Side-by-side view of shed and exterior wall.

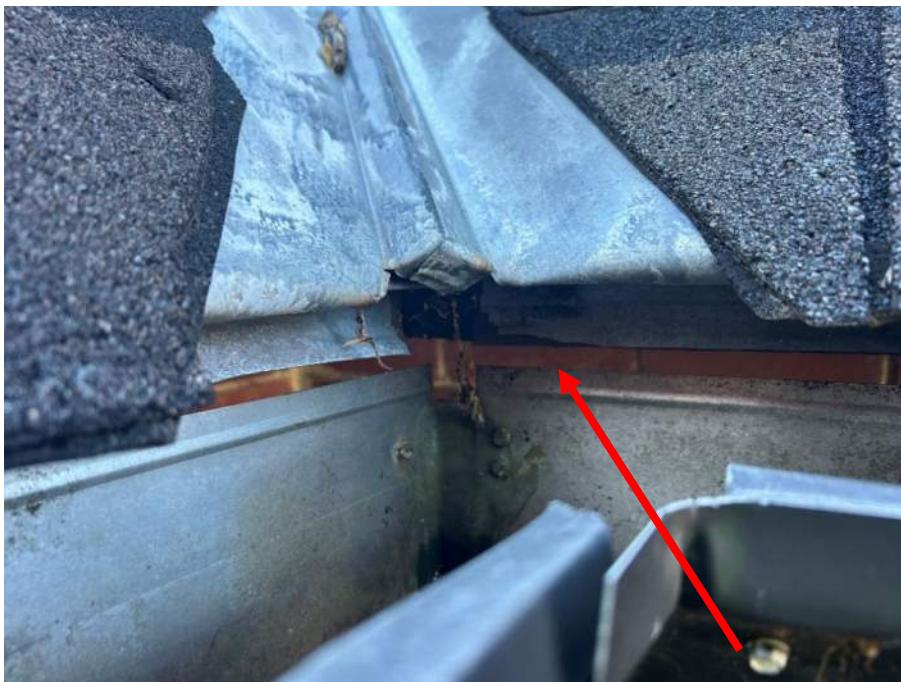
Gaps between valley and gutter.

Note that there is no secondary metal flashing between the valley and gutter.

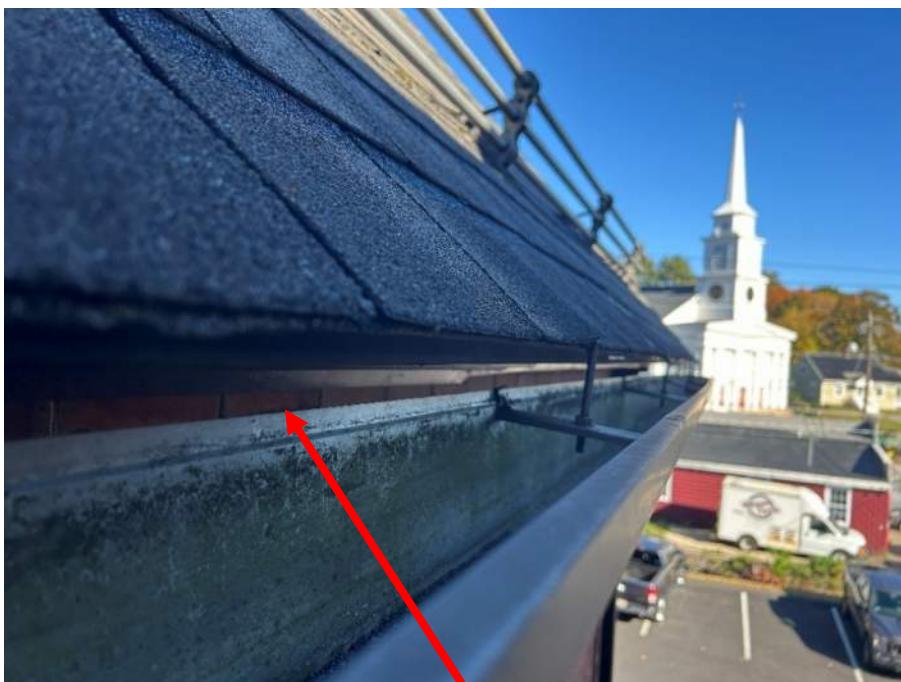
Gap between drip edge and gutter.

Note that there is no secondary metal flashing between the valley and gutter.

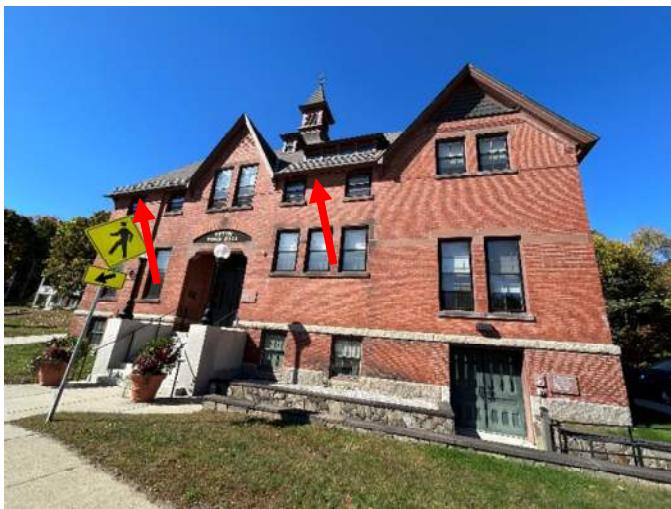
West (front) elevation.

The main roof drains over the roof edge, introducing bulk water onto the walls, windows and foundation walls below.

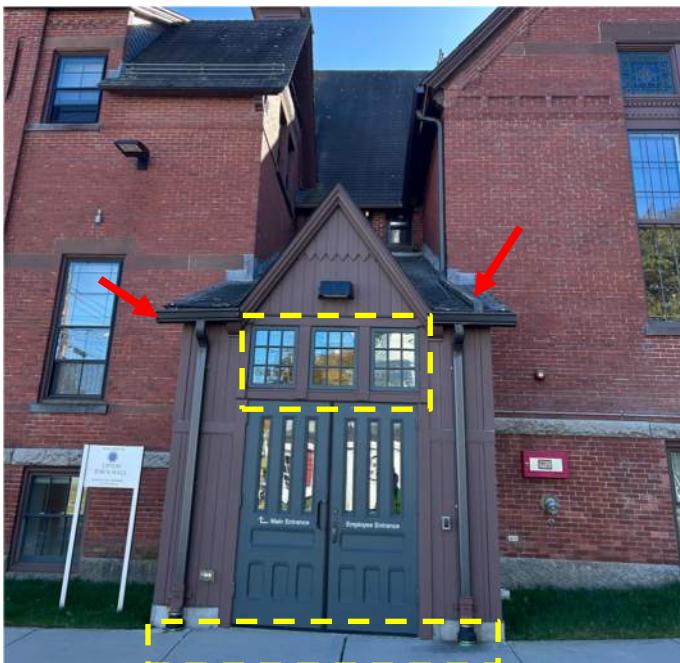
North elevation – employee entrance.

Gutter section to the left of the door is reverse pitched.

Gutter section to the right of the door receives discharge from the upper roof downspouts.

Leaks were reported at the transom window. Ice accumulation is also reported on the sidewalk in front of the door.

- d. Gutters, snowguards, heat trace elements and other accessories must be removed and replaced.
 - e. Re-route the upper roof downspout at the employee entrance into the main downspout leader.

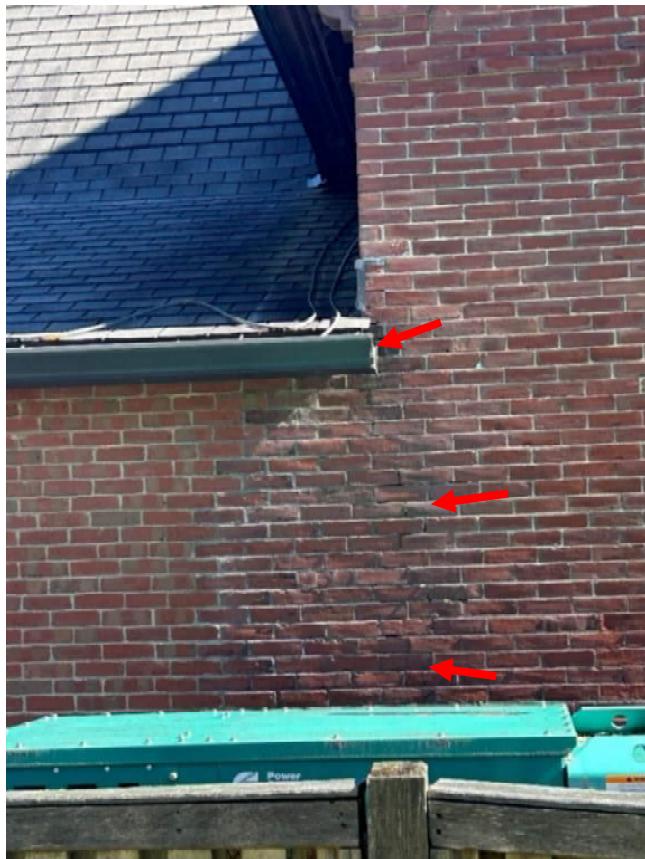
Deteriorated and discolored brick below a gutter with no kickout flashing.

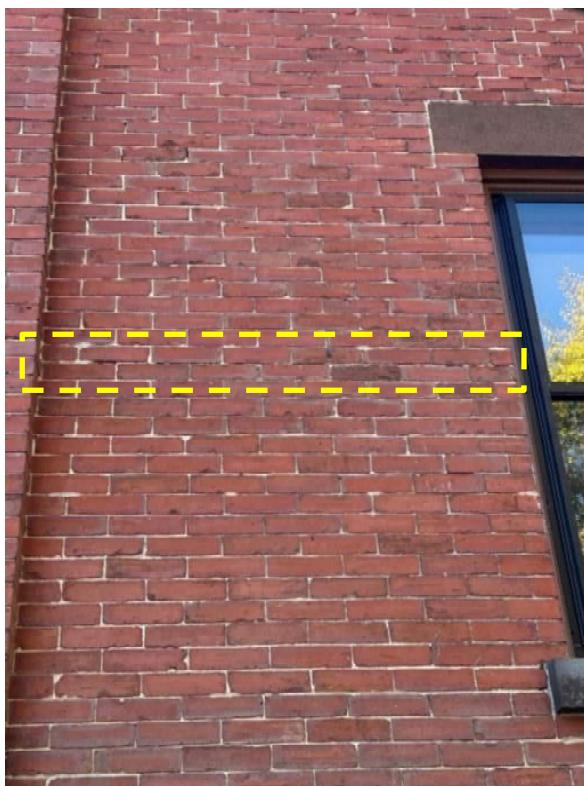
Scattered mortar joint deterioration and past pointing at North elevation.

Yellow area indicates a cracked/deteriorated bed joint.

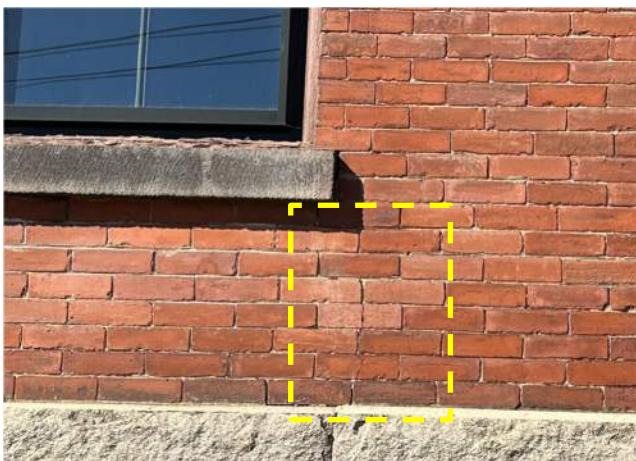
Vertical cracks extending from a window corner at East elevation.

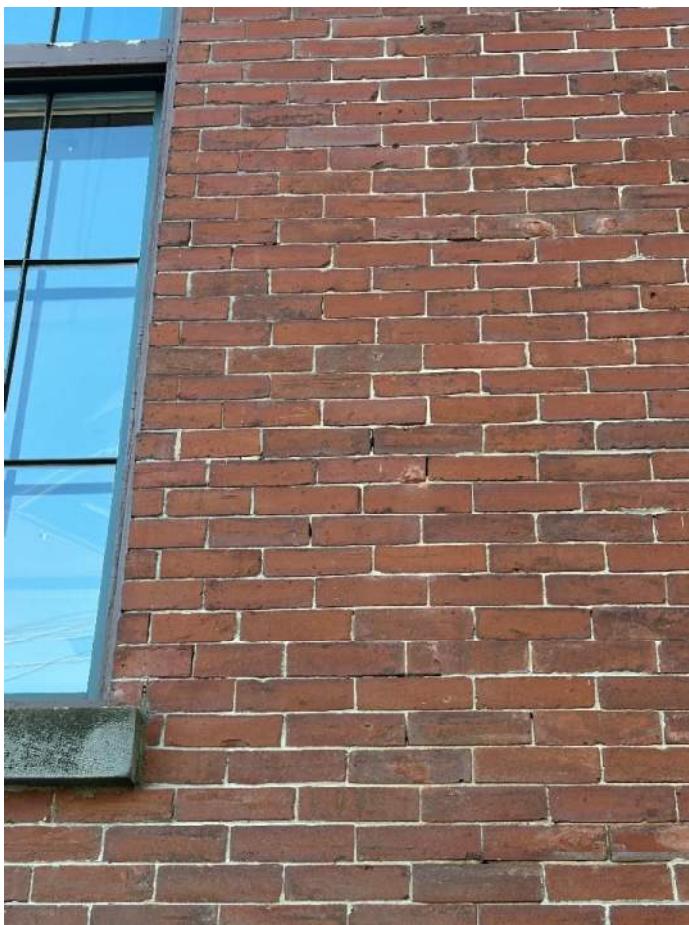
Deteriorated mortar joints at North elevation.

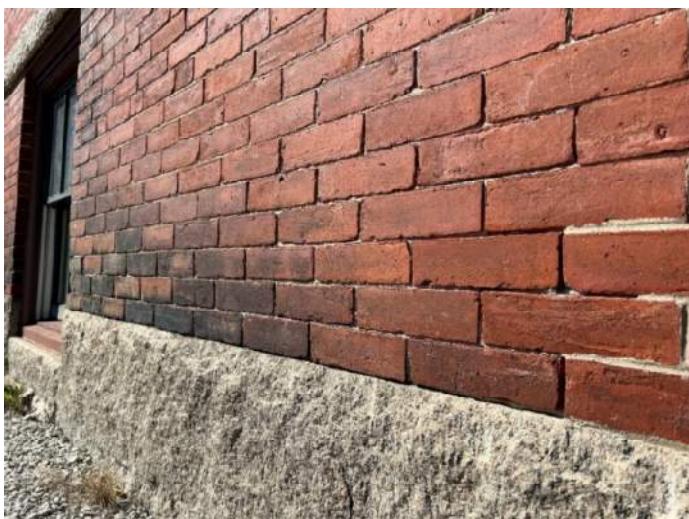
Deteriorated mortar joints at base of front (East) elevation wall. Note that the roof drains over the edge on to the wall and the ground in this area, increasing the moisture in base wall areas, and accelerating deterioration.

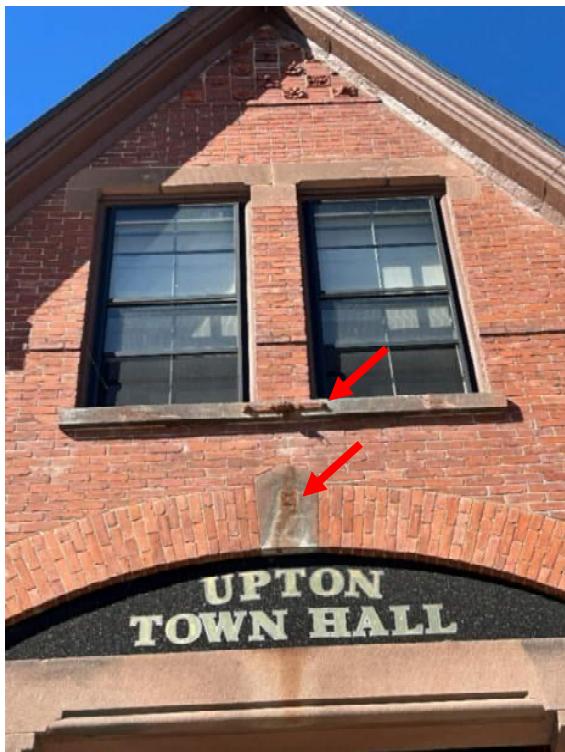
Corroded / abandoned mounting brackets and associated rust staining above main entrance to the building.

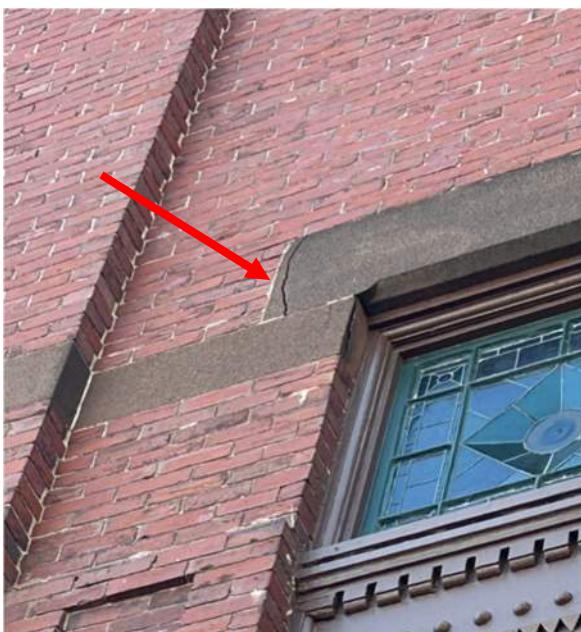
Delaminated / cracked brownstone lintel.

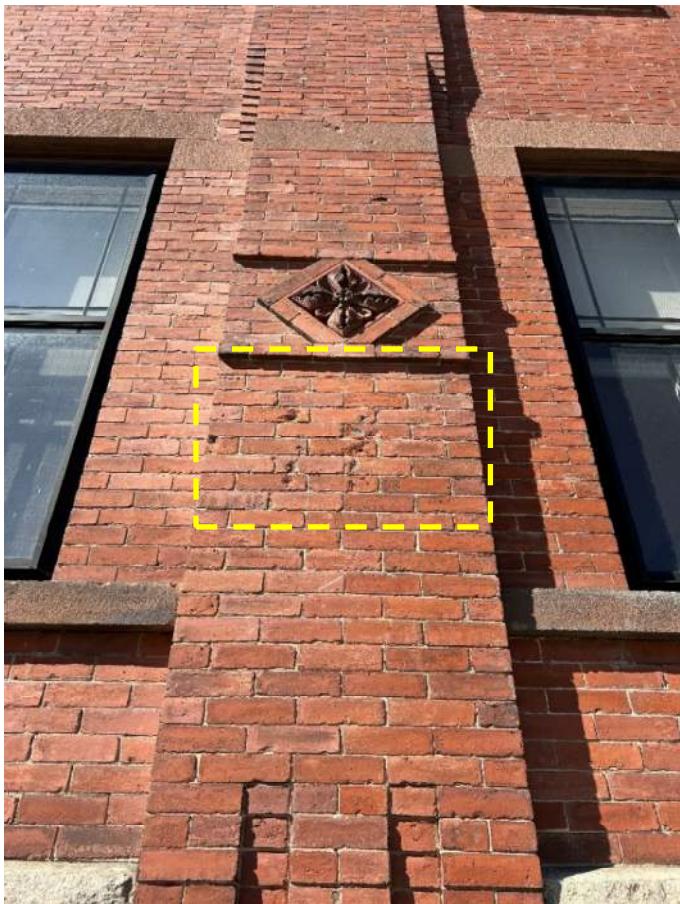
Concentrated area of spalled brick, apparently from previous mounting / attachment anchors that have been removed.

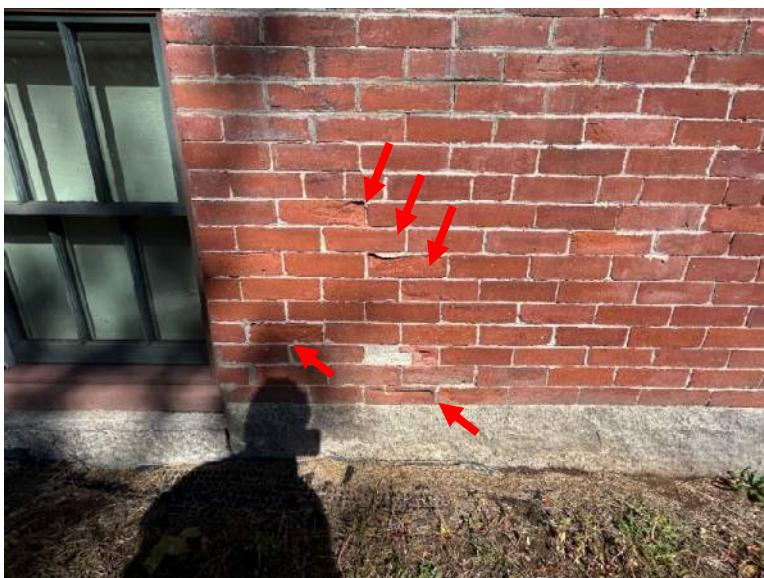
Spalled bricks were noted in select areas of past re-pointing and repairs. Portland cement-based mortars are harder and have a higher compressive strength than historic lime mortars. Material compressive strength incompatibility can cause bricks and adjacent mortar to spall and deteriorate.

Spalled face bricks in area of past re-pointing.

Attention is required to use appropriate mortar and materials for re-pointing historic brick.

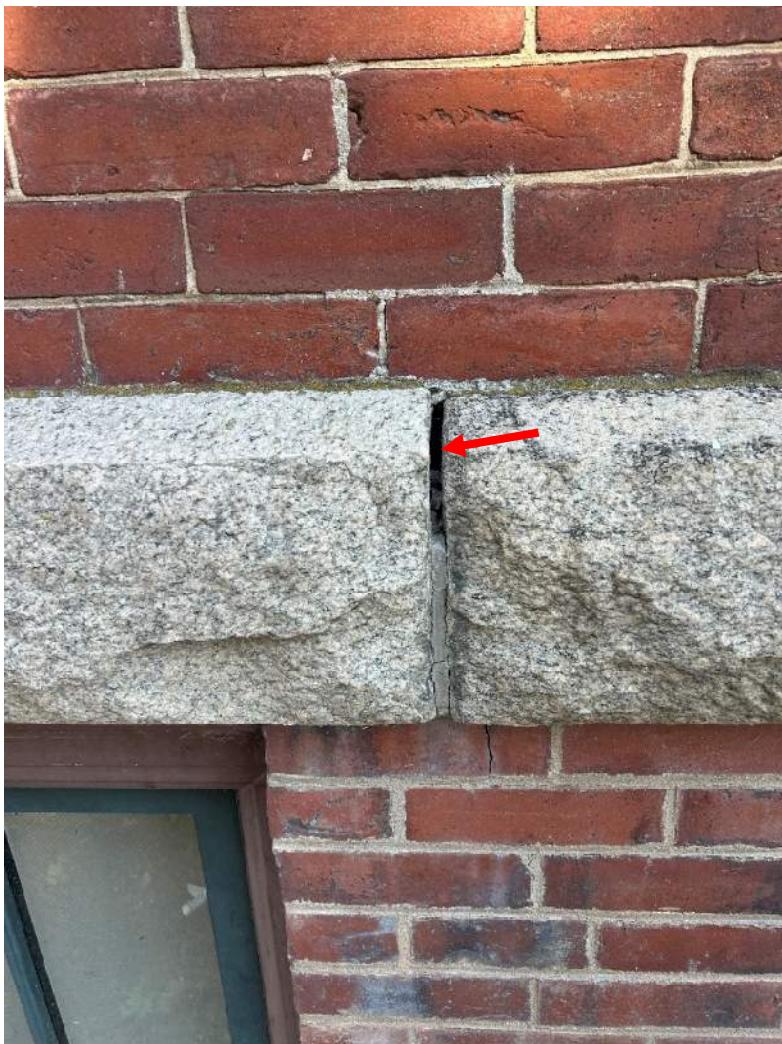
*Deteriorated head joints
between granite bands.*

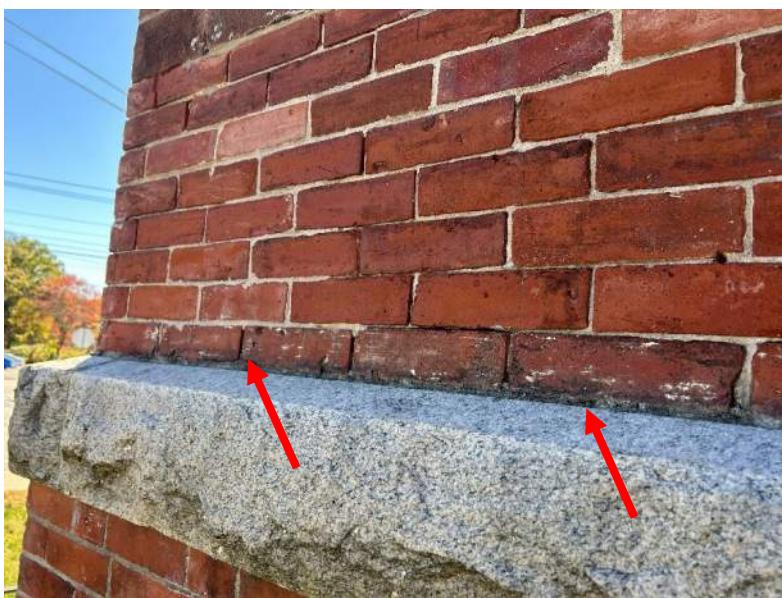
*Deteriorated bed joints at top of
brick rain table.*

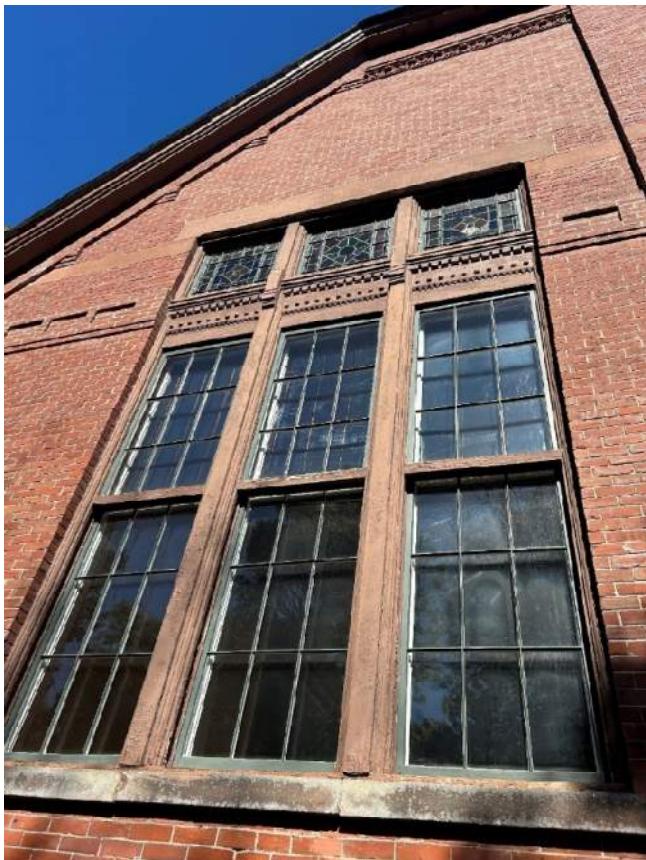
Overview of an auditorium window at the South elevation.

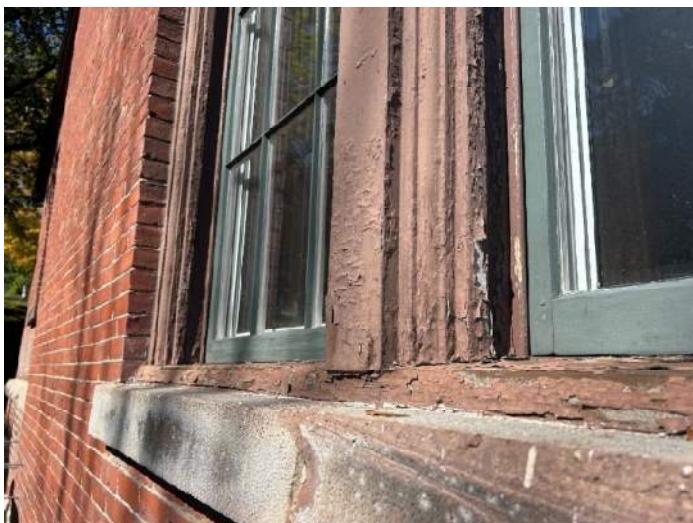
Detail view of auditorium window sill condition at South elevation. Note the peeled paint and deteriorated joinery.

- e. Repair and paint auditorium windows and miscellaneous wood windows that pre-date the 2013 restoration project.
- f. Perform targeted spall and crack repairs in the brownstone sills and window elements. Replace mortar joints around windowsill stones and granite rain tables with sealant.

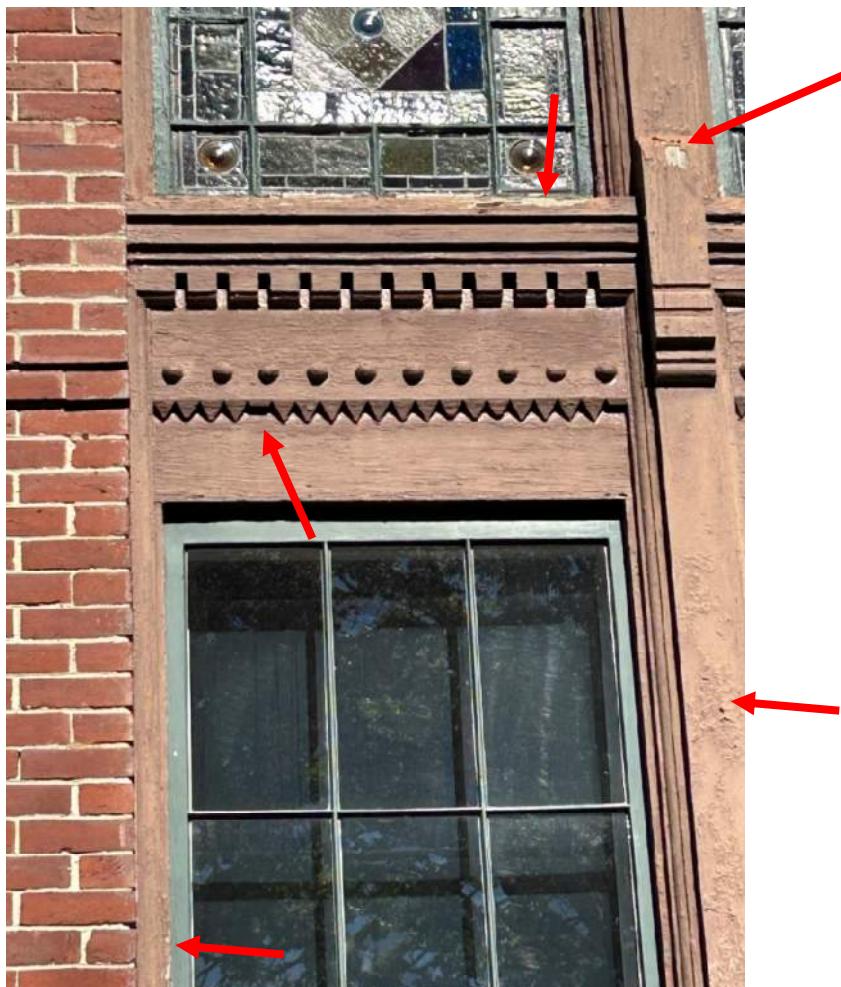
Deteriorated wood window details and peeled paint.

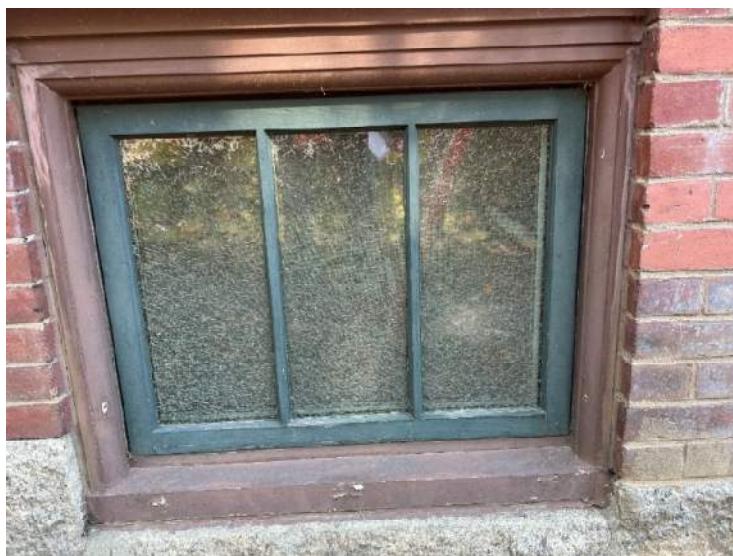
Shattered window at ground floor (South Elevation).

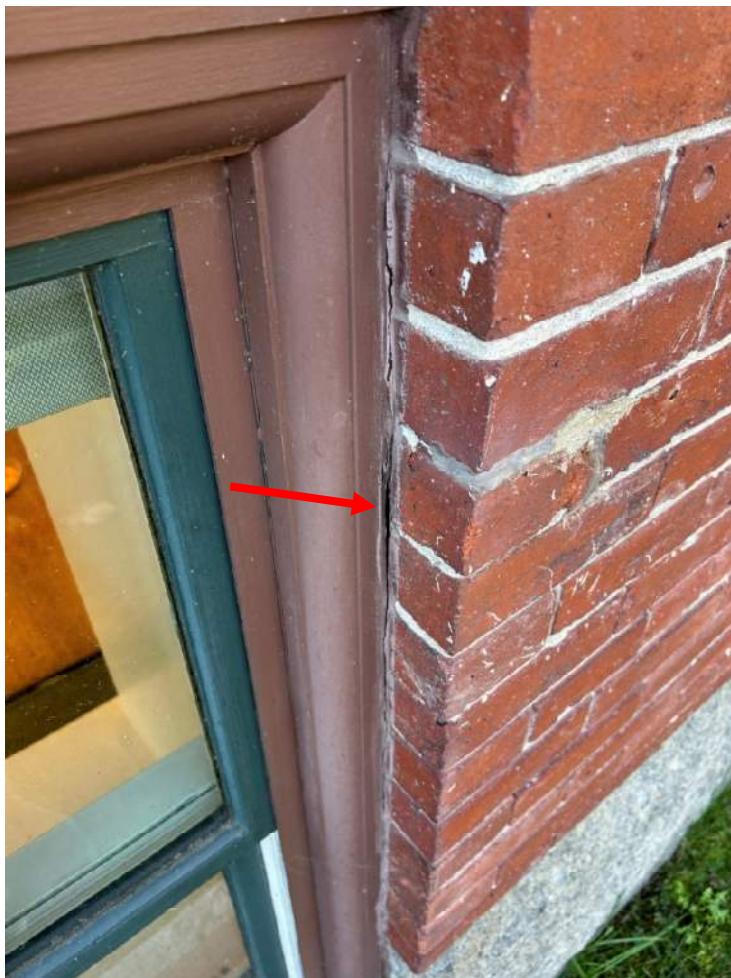
Failed sealant between window and brick.

- g. Replace sealants around windows, doors and penetrations.

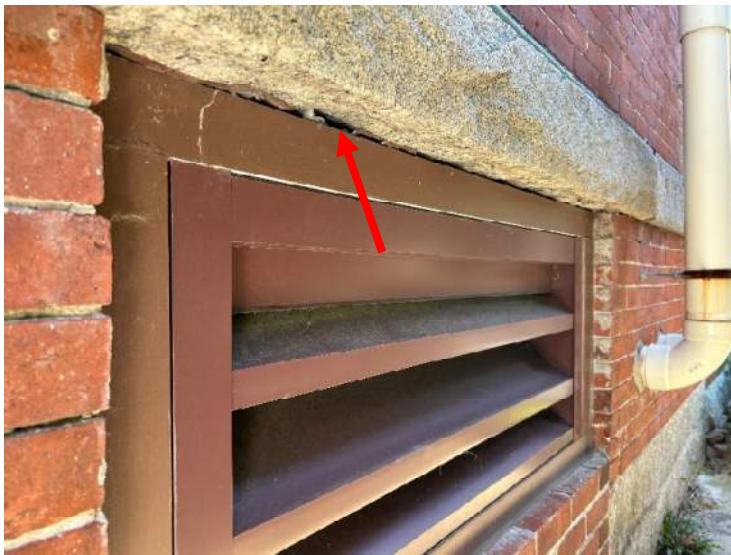
Poorly detailed and failed sealant between louver frame and granite band.

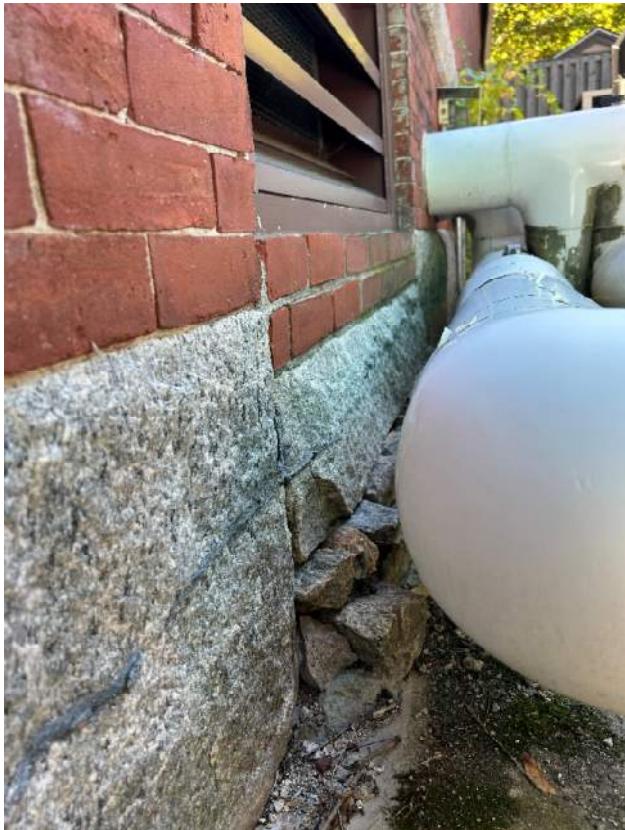
Deteriorated fieldstone foundation below louver.

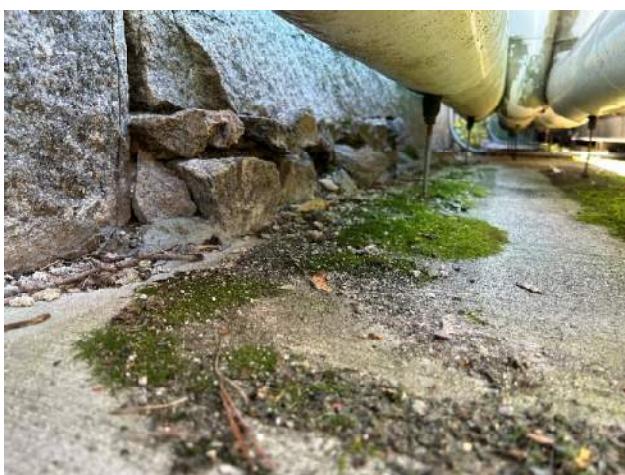
Loose/dislodged fieldstone units in mechanical well at West elevation.
