Upton Wastewater Treatment Facility
Upton, MA

Upton Wastewater Pump Station Evaluation

Upton Water Department
March 2020

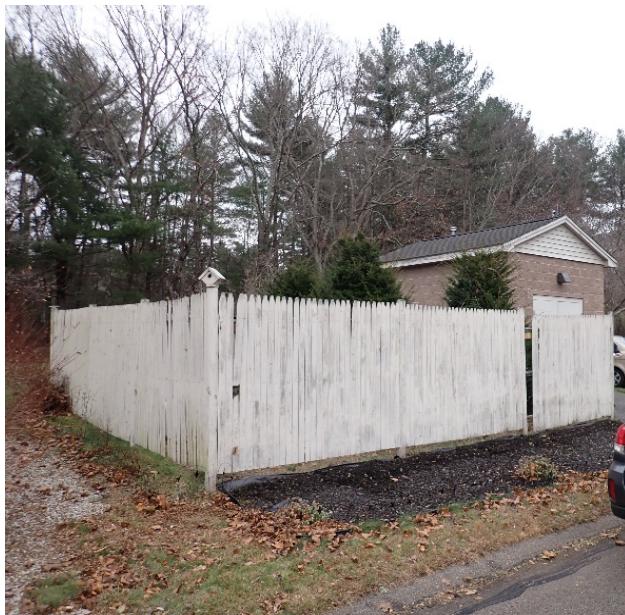
Josiah Drive Pump Station

The pump station building is in overall good condition with some exterior deficiencies. There is heavy staining and deterioration on the wood fascia boards as well as multiple roof shingles that are damaged. The exterior split-face CMU is stained in various locations, especially around pipe penetrations. The entry doors have peeling paint with rust stains, and the ceilings are stained. The wood security fencing around the site appears significantly worn.

The wood fascia boards should be stripped and painted, and the damaged roof shingles should be replaced. The entry doors should be cleaned and painted, and the roof should be examined for potential leaks. The wood fence on the site should be replaced in kind to provide adequate security and visual appeal due to the residential nature of this pump station.

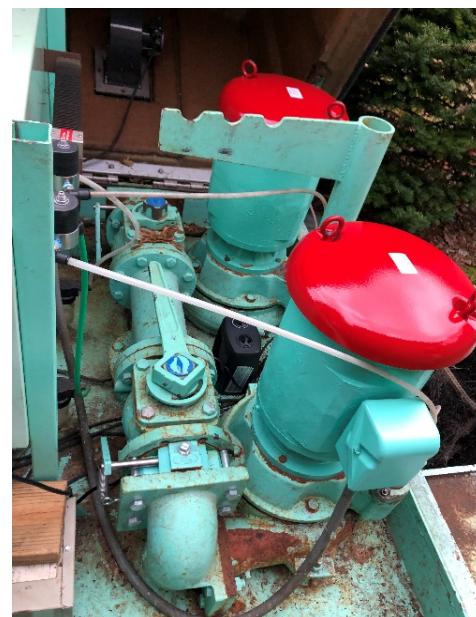
Pumping System

The pumps were originally installed in 1995 but have been upgraded recently and are in good condition. The sewer manhole does not appear to be accessed often and does not have fall protection. The enclosure for the pumps seems to be adequately weather-proofed. Both pumps started up when put into hand mode. The check valve closed smoothly and there were no signs of a water hammer.

Due to the recent replacement of the pumps, their expected useful life is further beyond the 20-year planning period. The ATS is outdated and the timer no longer works and should be replaced. The Pumping Station lighting should be upgraded to LED fixtures.

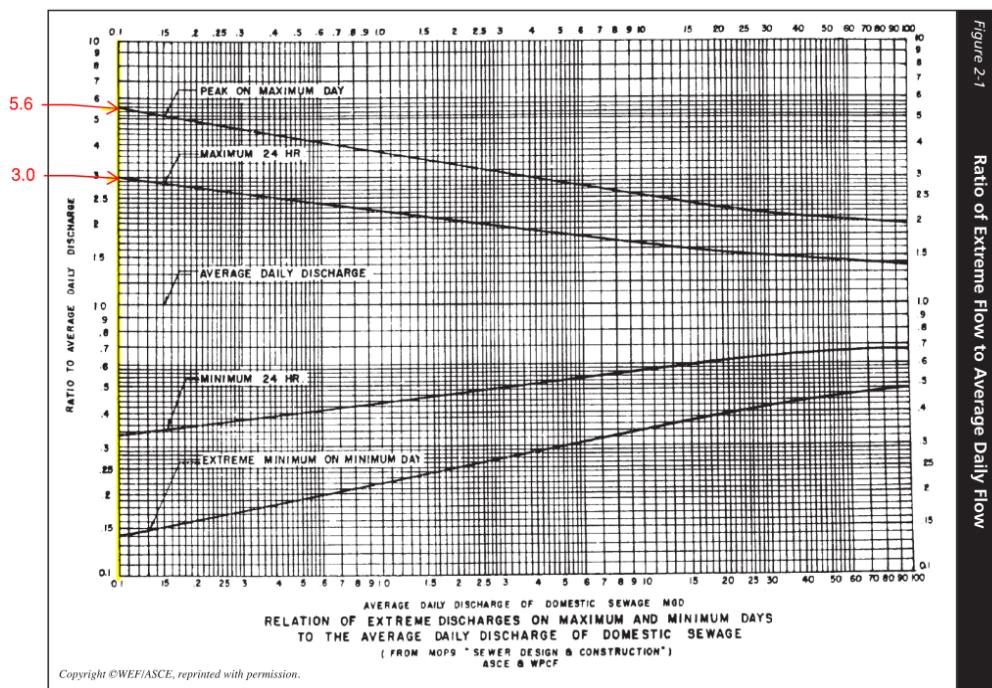
Figure 2-1: Relation of Extreme Discharges on Maximum and Minimum Days to the Average Daily Discharge of Domestic Sewage (from TR-16)

TR-16 Guides for the Design of Wastewater Treatment Works (2011 edition, revised in 2016) was used to estimate the peak influent flows. Figure 1 and the discussion below, show how the peaking factors was determined. The daily discharge of domestic sewage in million gallons per day (MGD) to the pump station is on average 0.01 MGD. Since the lowest value on the x-axis is 0.1 MGD, this was the value used to determine the peaking factors.

A maximum daily flow of 31,700 gpd was calculated using a peaking factor of 3.0 from Figure 1. The peak instantaneous flow of 41 gpm was calculated in the same way.

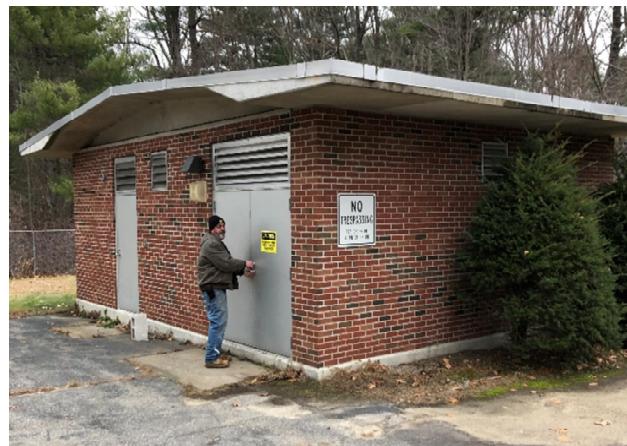
Station Street Pump Station

The building has an MCC in good working condition. The lighting switch to the wet well is no longer working and the fixtures can only be turned on with a pair of pliers. The Pump Station structure is in satisfactory condition with minor structural issues. The edges of the precast plank roof have dark staining, and there is efflorescence and staining on the exterior brick walls.

We also recommend upgrading the wet well ventilation system, removing the wet well heater and replacing a portion of the drywell equipment. The edges of the precast plank roof should be power washed. The roof is not accessible from the ground and should be further reviewed. Framing should be added to the metal grating of the wet well to stiffen the system. Grating panels should be replaced or reinforced over openings or where not adequately fastened. The door to the wet well should be cleaned and painted. The concrete floor and equipment pads on the lower level should be cleaned and coated, and the metal spiral staircase should be cleaned. The lighting should be upgraded to LED. The lighting should be replaced.

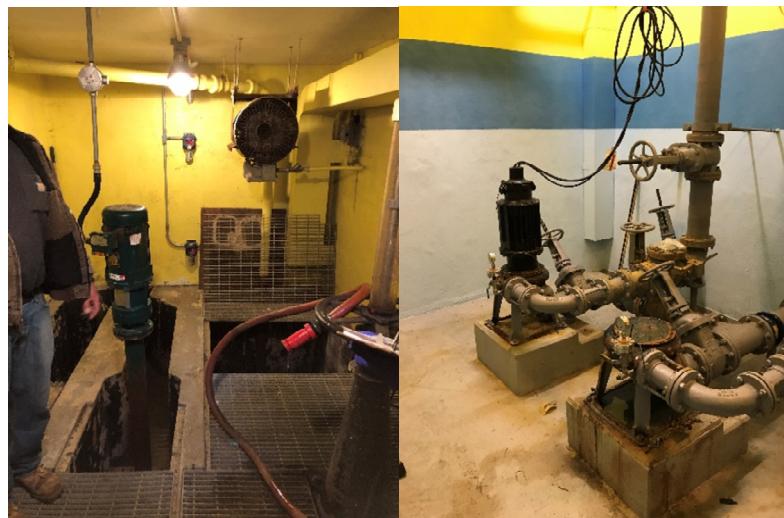
The grinder and bar rack are located in the upper portion of the wet well side accessible from an aluminum grating platform above the influent channel and wet well. Wastewater flows from the channels into an approximate 3,800-gallon wet well divided into two sections, separated by a sluice gate (normally open). The wet well is approximately 9-ft 11-in wide by 8-ft 10-in long and 4-ft 9-in deep with an infill volume of approximately 1,500-gallons. The fillets in the wet well are at a 1:1 slope and account for approximately 30% of the wet well area. It maintains a normal operating range of 2-ft 9-in to 4-ft 9-in above the wet well floor.

The Pump Station has three 7.3HP Fairbanks Morse, model D5432WD, dry-pit submersible solids handling pumps. The suction inlet diameter is 4-inches and the discharge outlet diameter is 3-inches. Each pump is designed to operate at approximately 215 gallons per minute (gpm) at 52-feet of head and 310 gpm at 57-feet of head. The shutoff head of the pump is 76 feet. The pumps operate as lead, lag, and standby and the station operators typically rotate the pump sequence at least once a month. After the sewerage is conveyed through the Pump Station, the flow continues through an 8-inch cast iron force main along Station Street and Pleasant Street where it discharges into a 15-inch gravity sewer main near the intersection of Pleasant Street and Warren Road.

Influent Channel Grinder and Pumps

The grinder pump and bar rack appeared to be in good working condition. The pumps in the Station Street PS appeared fairly new and were in good working condition. The process piping and valves appear to be in fair condition with no reported issues with operations. A new gas monitoring system was installed on the wet well side of the pump station approximately 2 years ago. Operators reported significant grease and debris build up in the wet well influent channel. They have no reported any odor problems. The wet well has metal grating which exhibits significant deflection when loaded. The concrete floor and equipment pads on the lower level of the station have moisture staining from equipment.

We recommend that the influent channel and wet well be fully cleaned to remove debris that may be inhibiting the pumping process. The cost for replacement of the existing process mechanical valves, equipment and instrumentation should be carried for future work at the station. During this future replacement, sandblasting and repainting of the existing process piping should be sufficient to increase the useful life of the drywell piping.
