Upton, MA

Nutrient Source Identification Report

MS4 Permit Year 4

June 2022

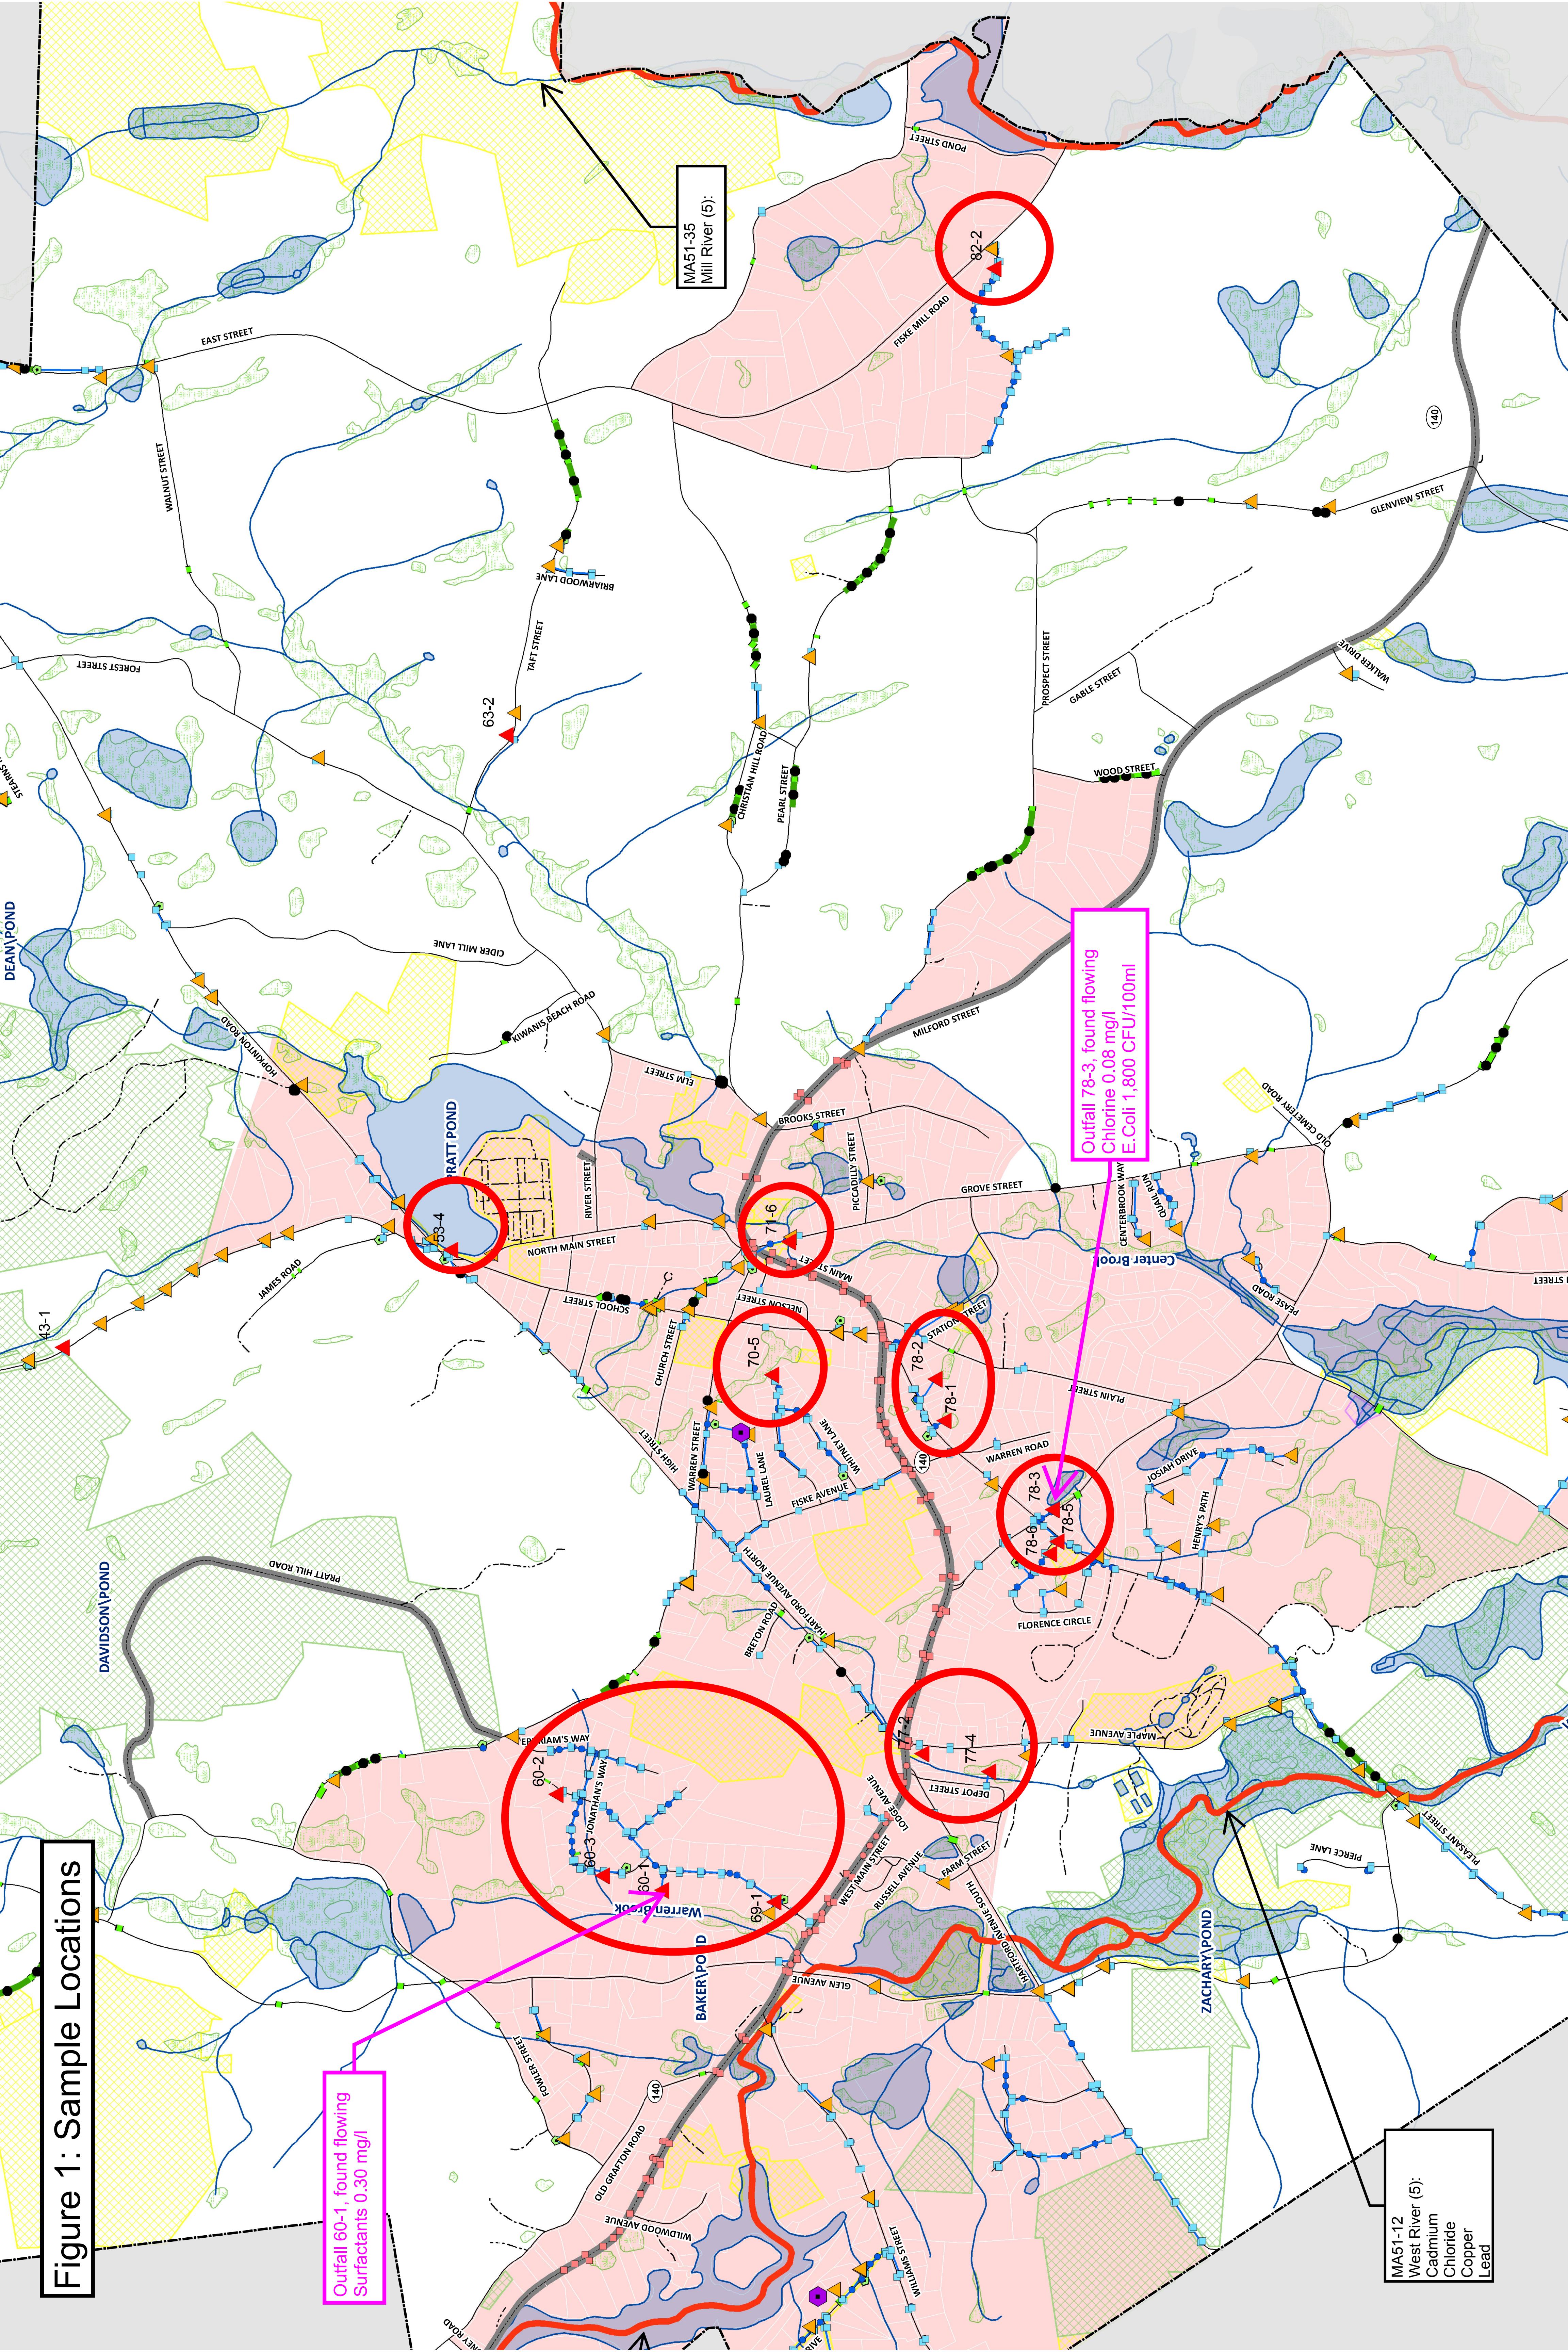
Figure 2: Outfall 60-1

Outfall 60-1 –BETA visually inspected and tested key junction MH 60-4 on July 24, 2018. Pipes entering MH 60-4 from Merriam Way and Nathaniel Way both tested positive for surfactants and chlorine. Field tests were conducted July 30, 2018 on all flowing manholes upstream of MH 60-4. Manhole 60-5 was the only flowing MH and tested positive for Chlorine (**0.62 mg/L**) and Surfactants (**0.25 mg/L**). All other drainage structures upstream of MH 60-4 on Merriam Way and Nathaniel Way were visually inspected for other pipe connections. Multiple plastic pipes were found discharging into catch basins. See Figure 2 for identified Catch Basin connections. Testing results for OF-60-1 can be found in Table 1 (attached).

Dry-weather screening and sampling found evidence of contamination at two of the fifteen outfalls. Outfall **60-1** was found to have **0.30mg/L** of surfactants, and the key junction MH 60-4 was found to have contamination from both chlorine and surfactants. A catchment investigation indicated pipes entering catch basins on Merriam Way and Nathaniel Way. A direct connection to a catch basin is not always illicit, these pipes could be from a sump pump, floor drain, or discharging wash water. Outfall **78-3** was found to have **0.08 mg/L** for Chlorine and **1800 CFU/100mL** for E.Coli. There are no records of sewer on Mendon Street and most of the homes were built in the early 20th century, which indicates most homes are on septic. There are records of sewer on Pleasant street, with a main crossing the drainage pipe.

MH 60-4 found flowing 7/24/2018
Merriam Way Flow:
Surfactants: 0.25 mg/L
Ammonia: 0.00-0.25 mg/L
Chlorine: 0.16 mg/L
